# Manning Creek Improvements as part of the Kuhla'Napo Wetland Preserve Restoration Project on Clear Lake, CA

**Angela De Palma-Dow & Merry Jo Velasquez,**  
Lake County Land Trust  
**Skyler Lewis & Anthony Falzone,** FlowWest  
**Sarah Ryan & Alfred Balletto,** Big Valley Rancheria

# Today: Planning Project 292-acre Kuhla'Napō Preserve in Big Valley Wetland Complex on Manning Creek

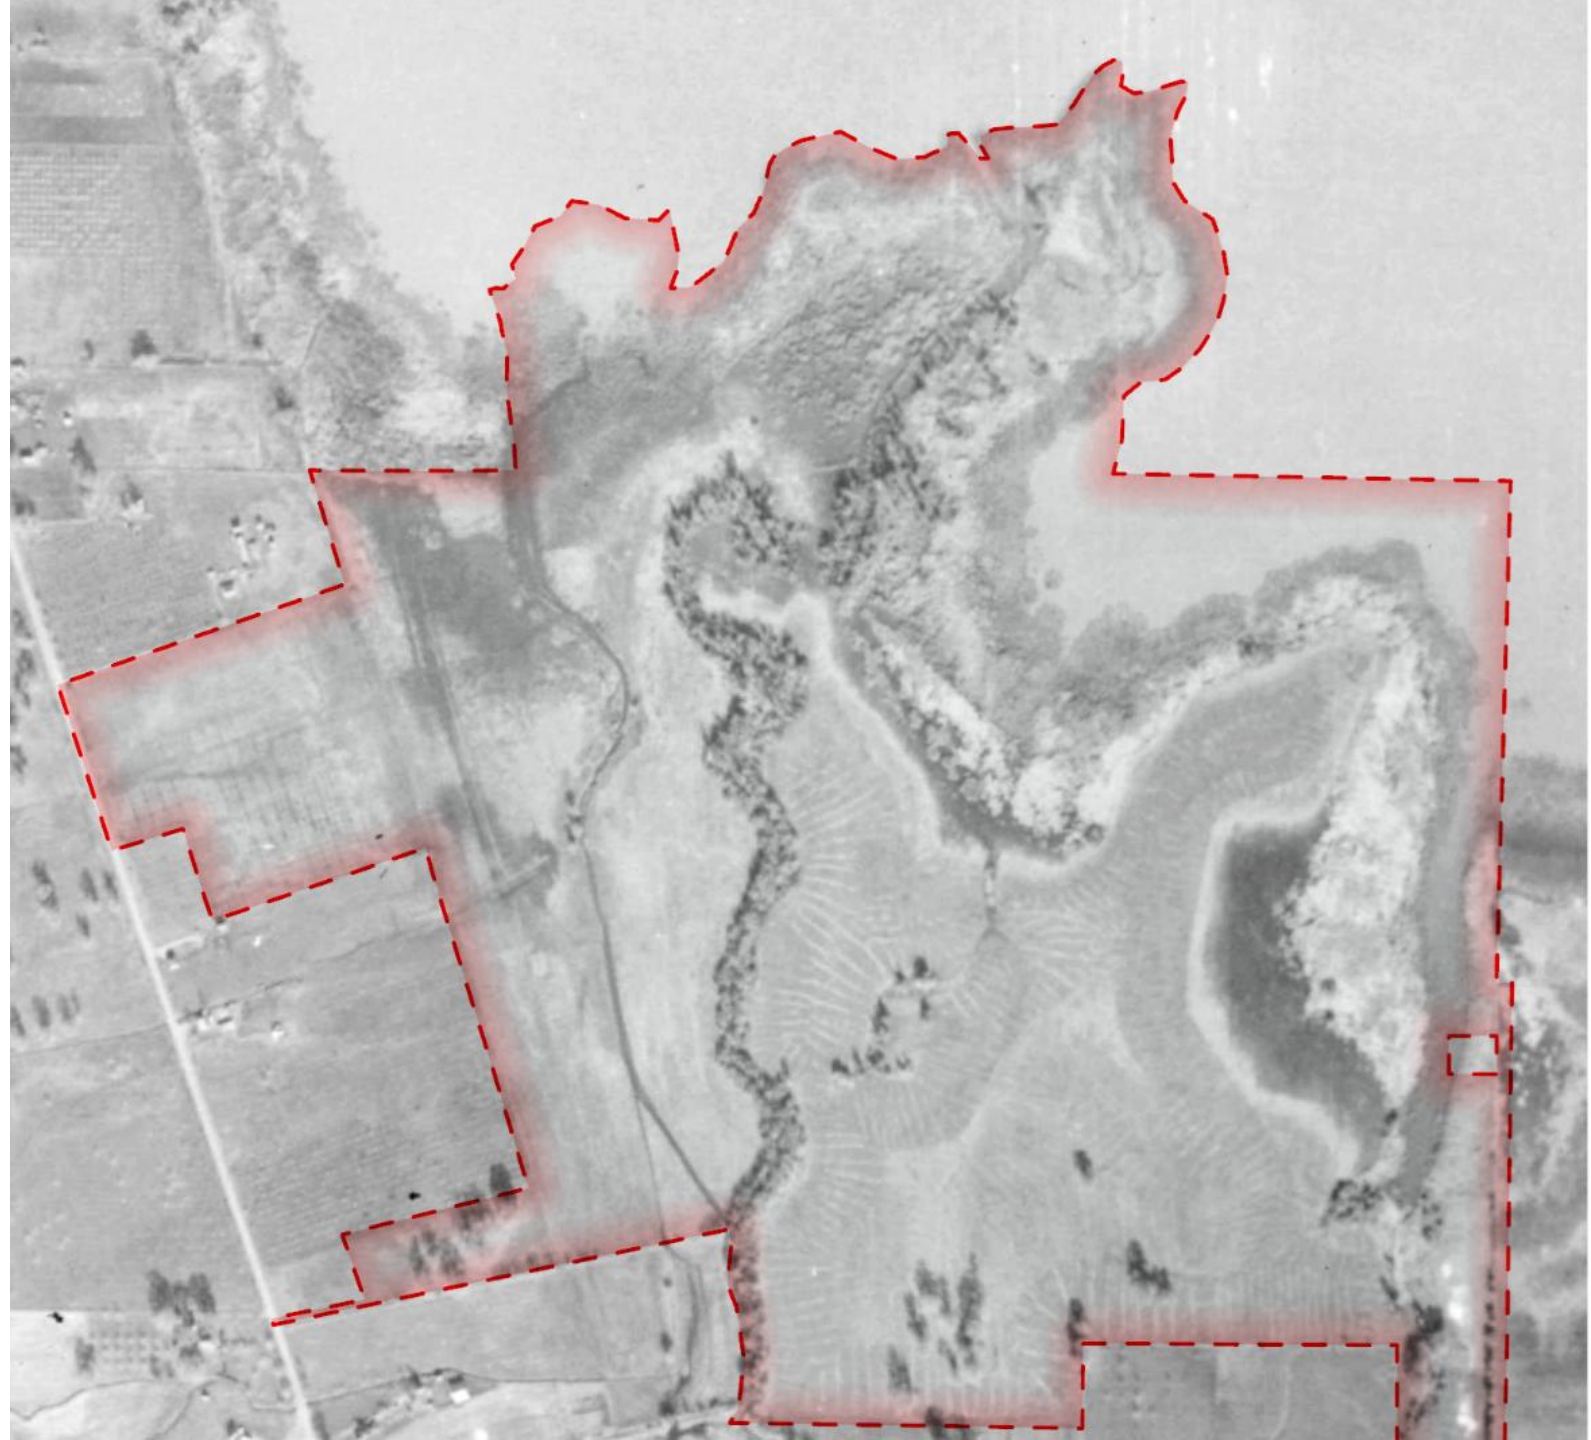
# Manning Creek Delta 1942

- Manning Creek flows through east branch riparian corridor
- Connects to lake at Manning Creek Delta tule wetland complex

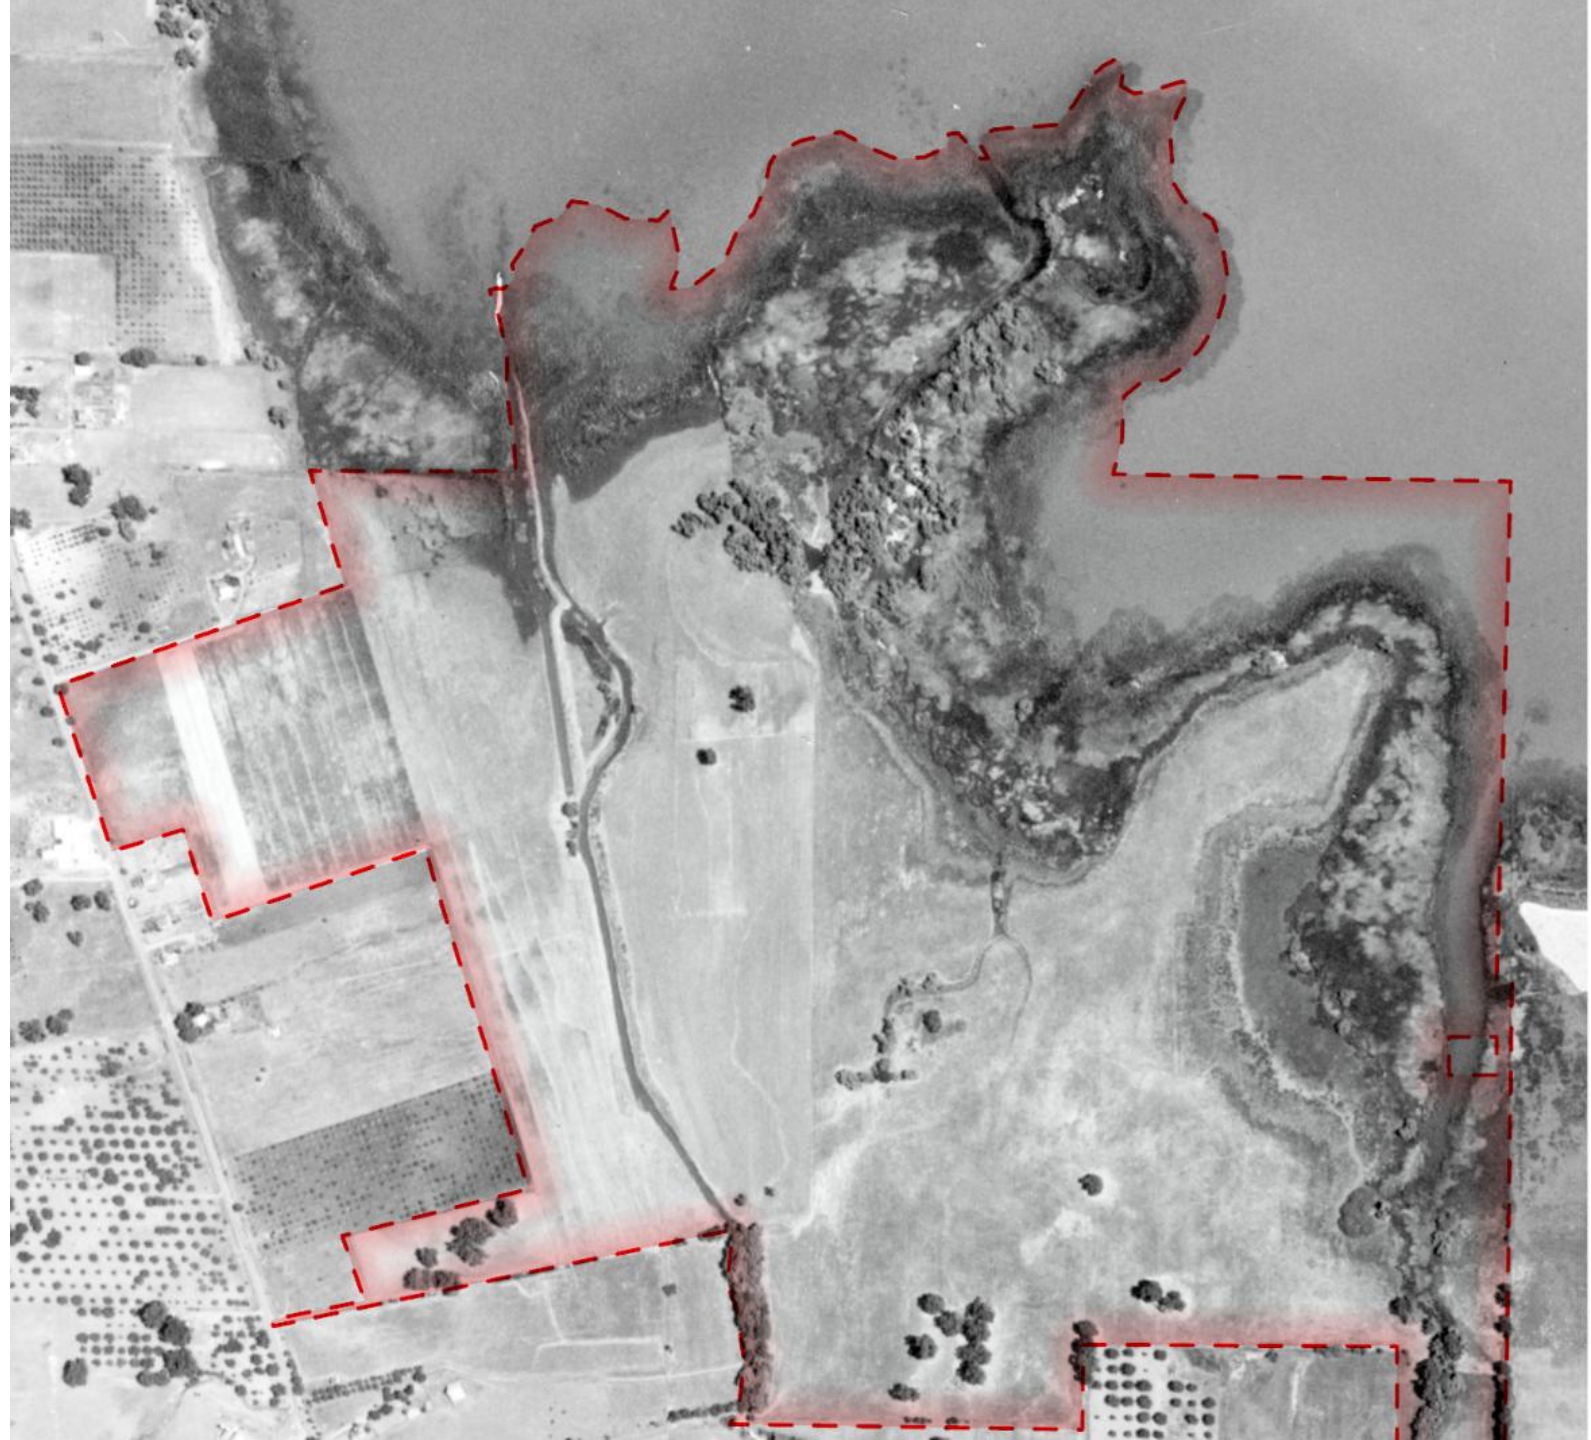
# Manning Creek Delta 1952

- Poof! Manning Creek east branch riparian corridor is gone
- Flow redirected through west branch agricultural canal

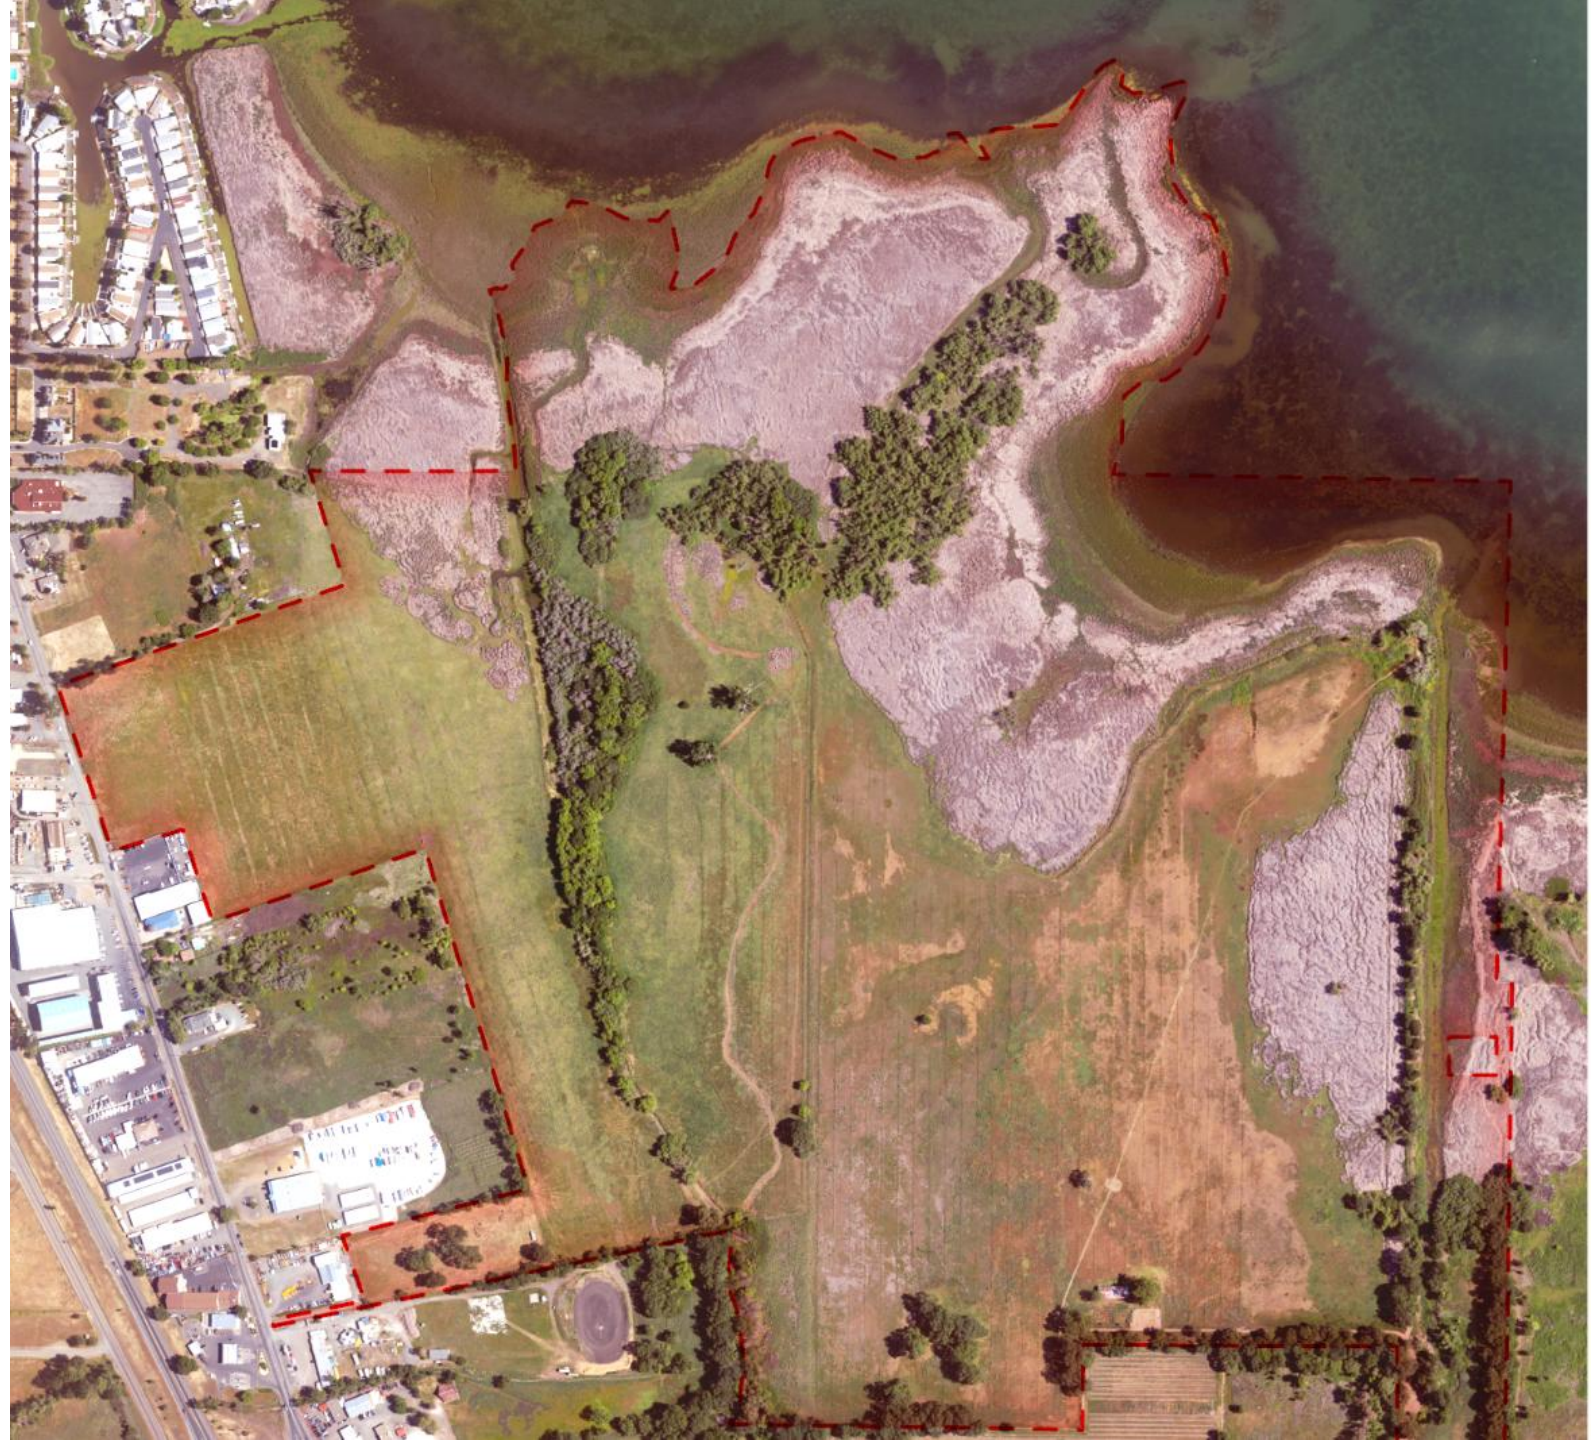
# Manning Creek Delta 2022

- Steep head cut on west branch creates hitch passage barrier
- East branch continues to flow as a secondary channel
- Tule wetlands are partly disconnected from the rest of the floodplain by levees

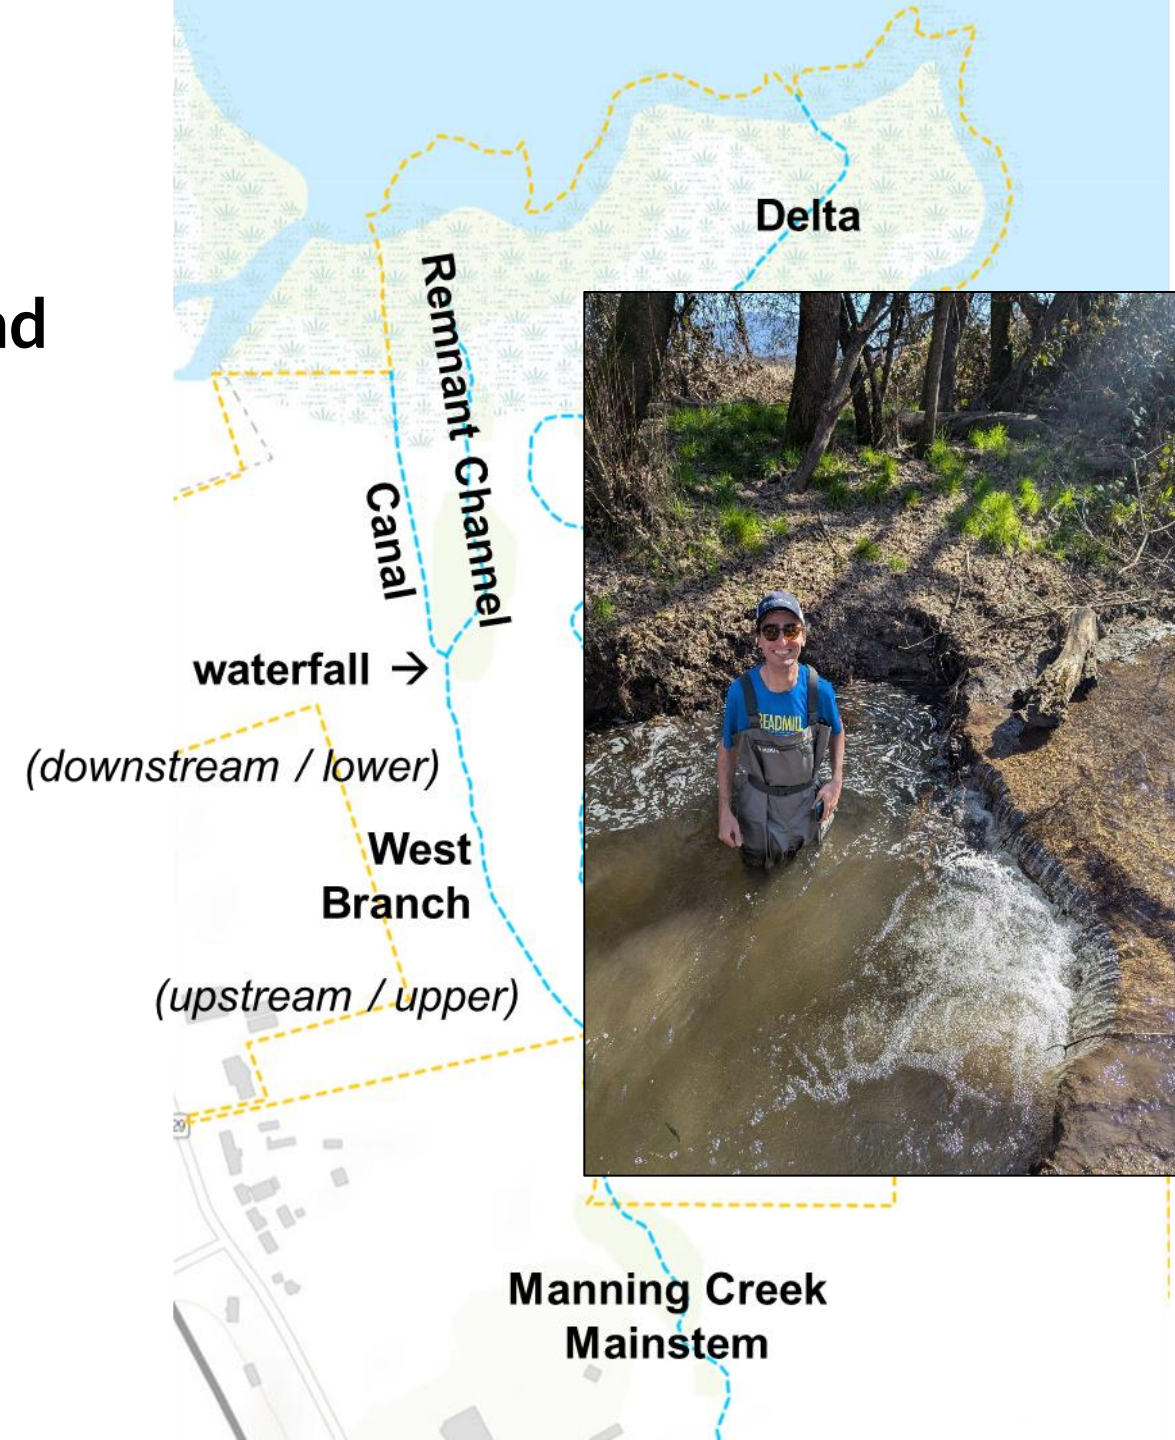
# Current Issues on Site

- Delta, wetland, and creek alteration and disconnection
- Creek modification
  - Erosion & Sedimentation
  - Flooding
  - Fish Barriers
- Wetland Removal
  - Reduced natural shoreline
  - Reduced native vegetation

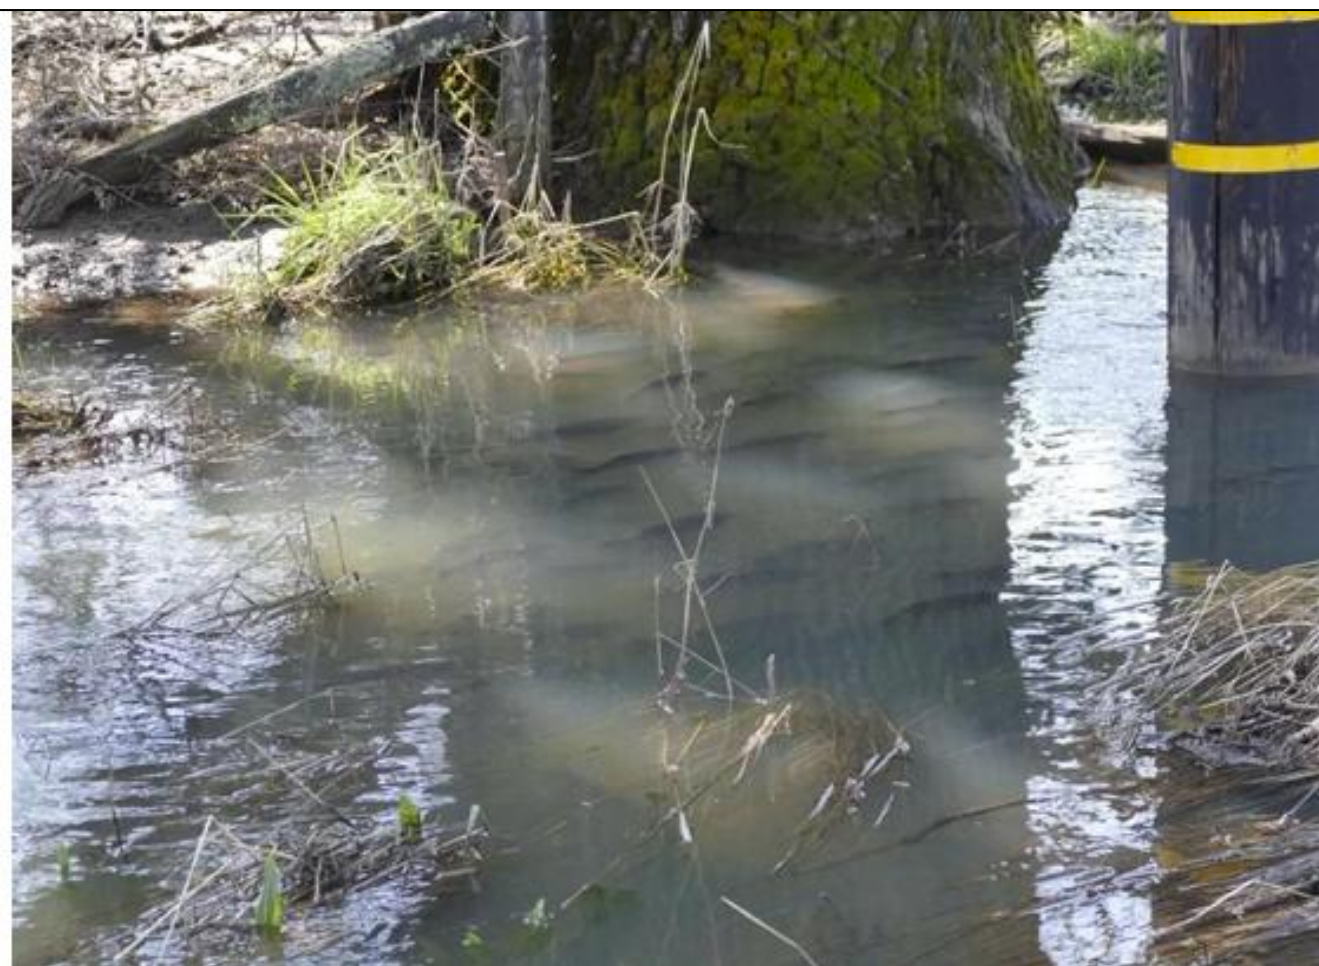
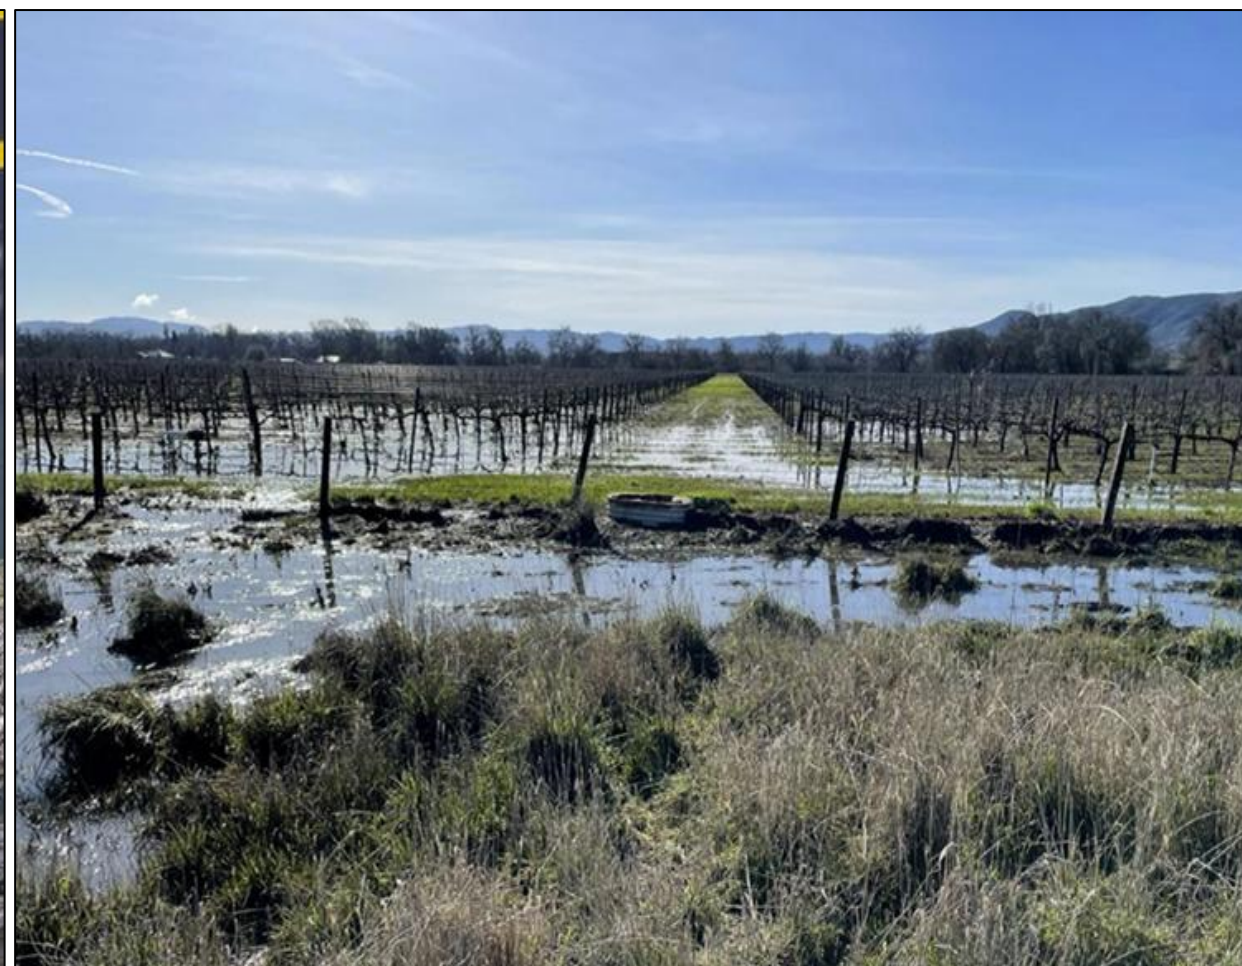
# Fish barriers and Flooding at site

*Contribute to fish strandings, sediment and nutrient leaching – wetland & floodplain disconnection*

West Channel Manning Creek straightened,  
deepened, native vegetation removed and  
previous wetland drained

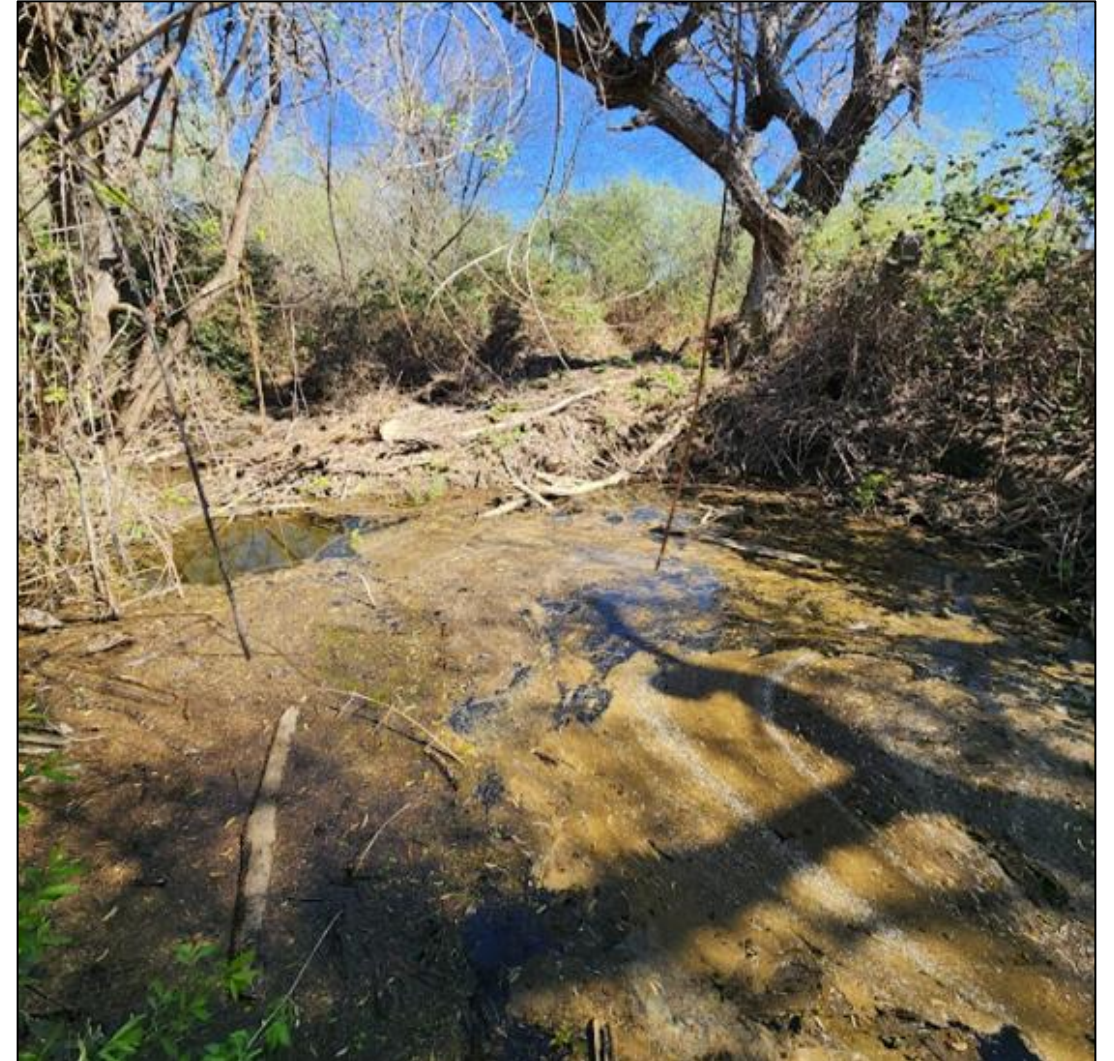
Remnant secondary Manning Creek  
Channel, blocked, debris accumulation,  
contributes to erosion and blow outs

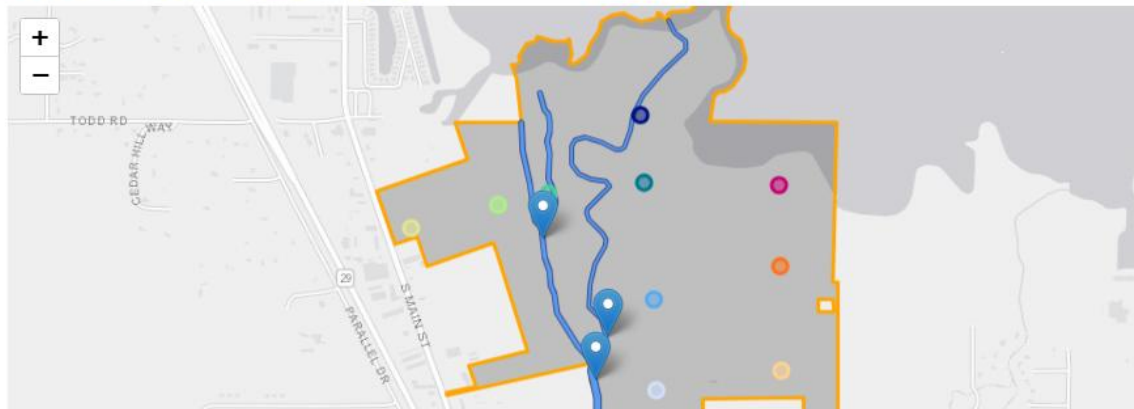
## MONITORING LOCATIONS

- Shallow Groundwater Elevation
- Creek Stage and Temperature
- Real Time Data on our Restoration Website:

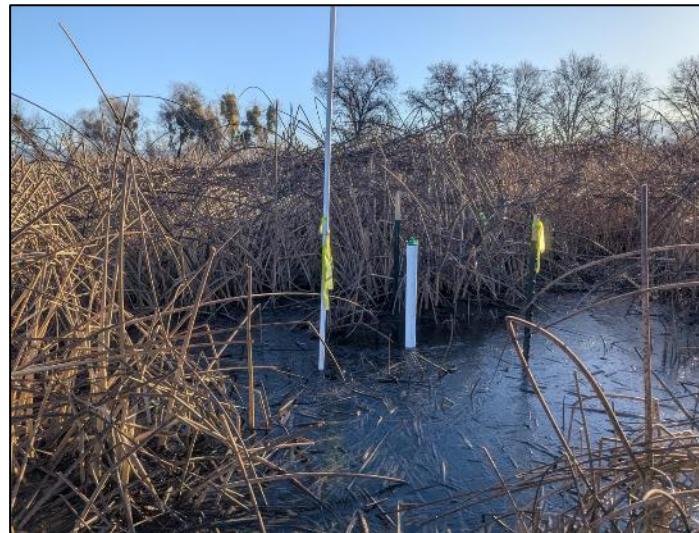
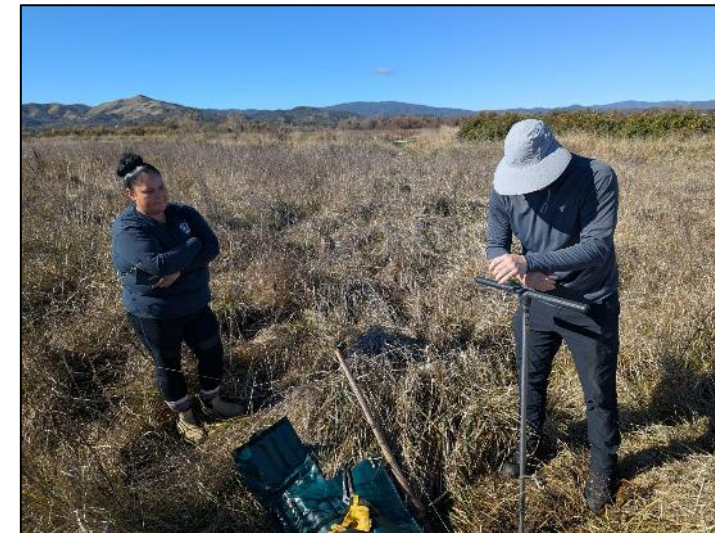
# Data for Design

- Shallow Groundwater Elevation
  - Hand augered 10 shallow groundwater monitoring wells
  - Tribal monitor
  - Installed in transects to capture different
    - soil types
    - vegetation communities
    - distance from the lake

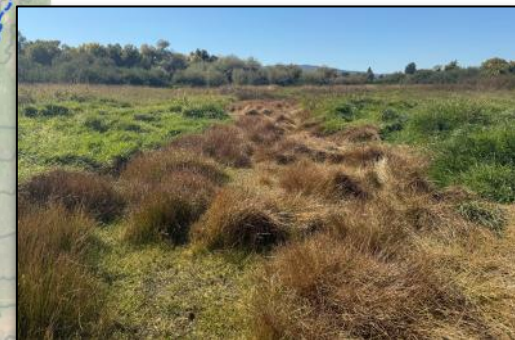
# Restoration Plan: Manning Creek

## Design goals:

- Keep more flow in the channel to reduce stranding and maintain passage
- Eliminate headcut barrier that is present when lake levels are low
- Restore historical channel alignments

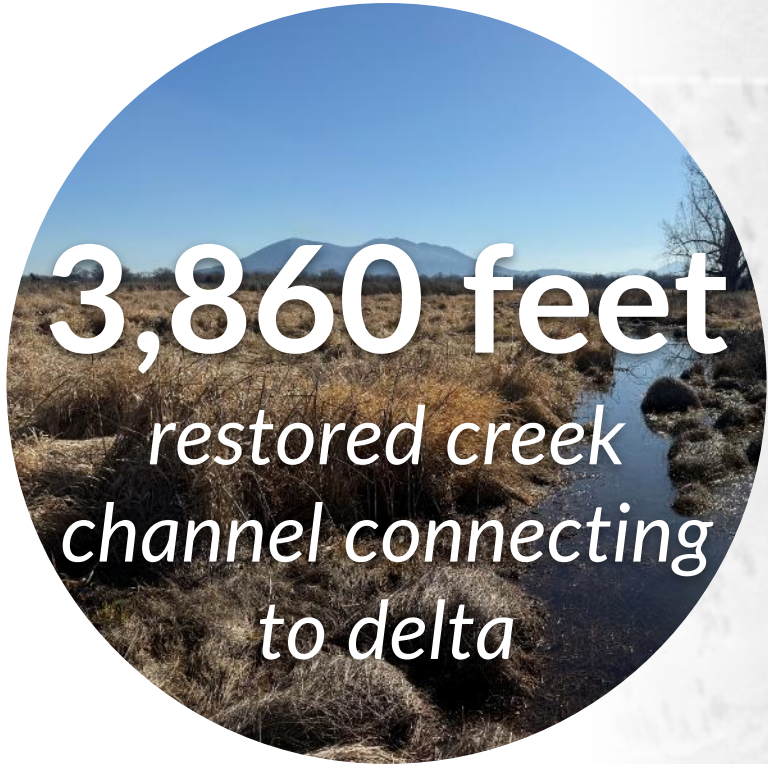
**3,860 feet**

*restored creek  
channel connecting  
to delta*

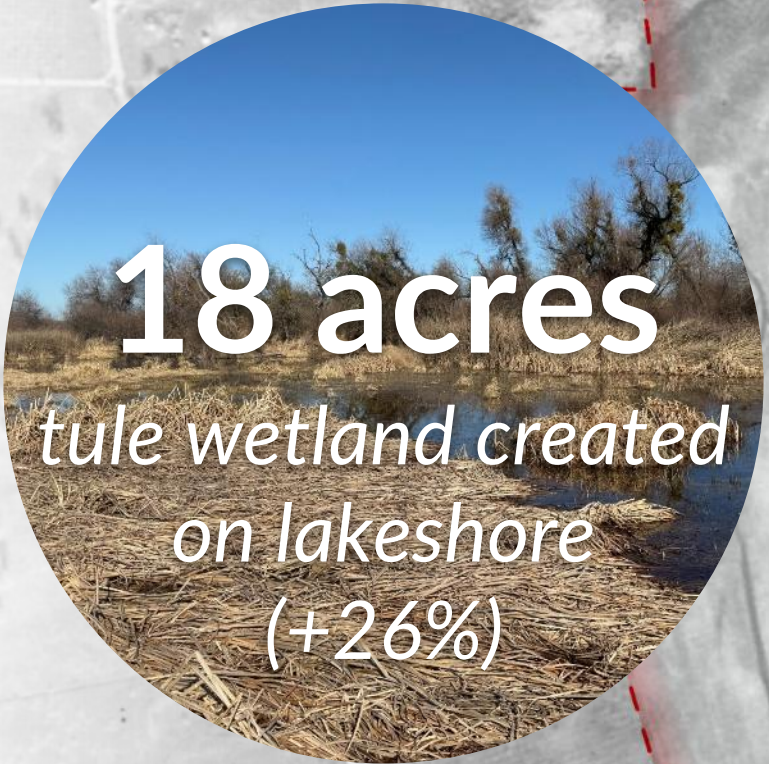
**18 acres**

*tule wetland created  
on lakeshore  
(+26%)*

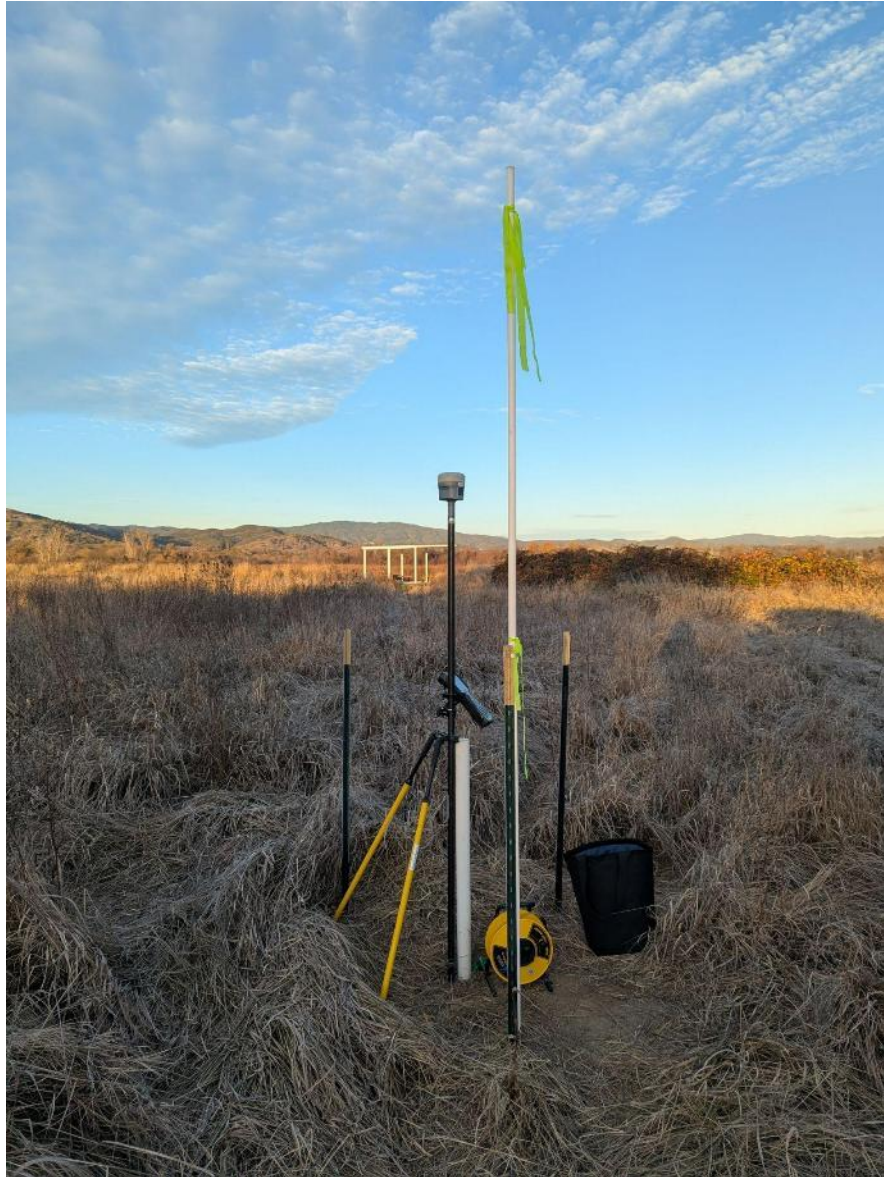
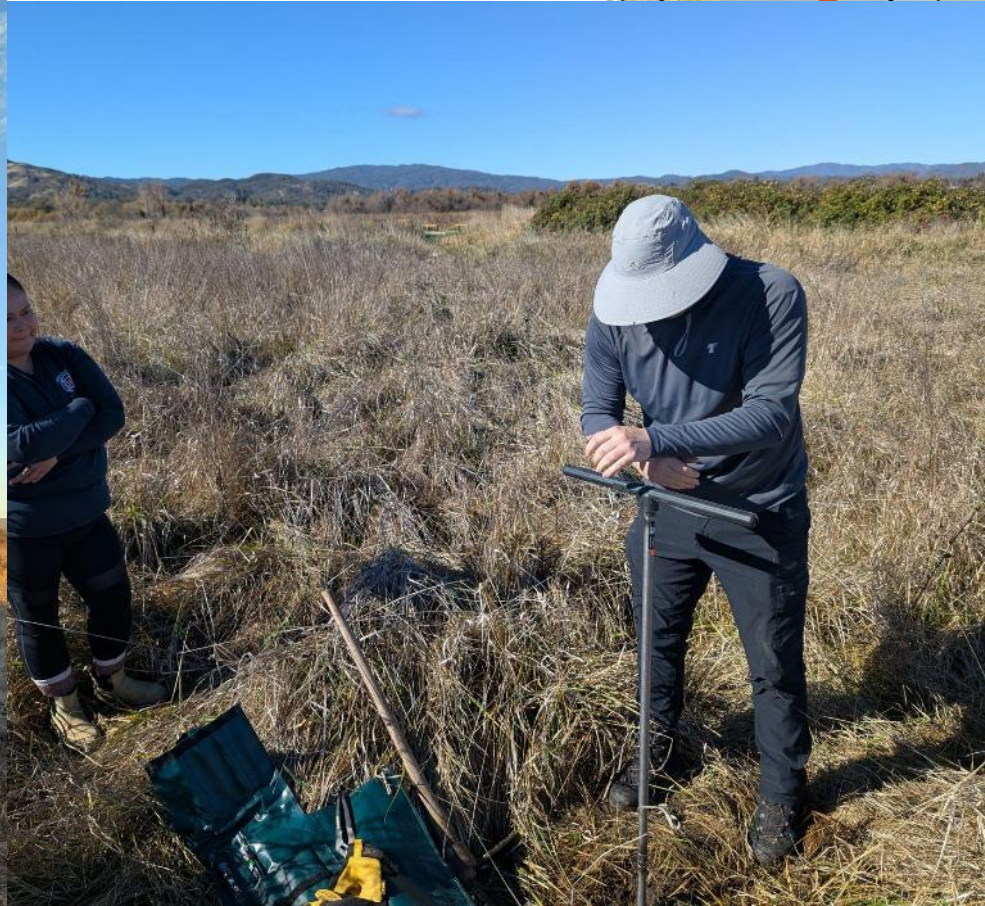
- ▲ Stage Gages
- ▲ Piezometers
- ..... Piezometer Transects
- ▭ Project Boundary
- ▭ Parcels
- 3 ft contours
- 1 ft contours
- - - Manning Creek West and East Branches

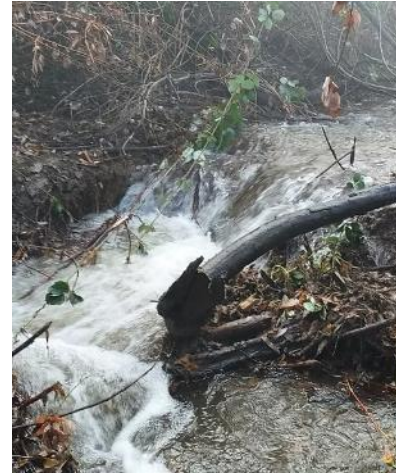
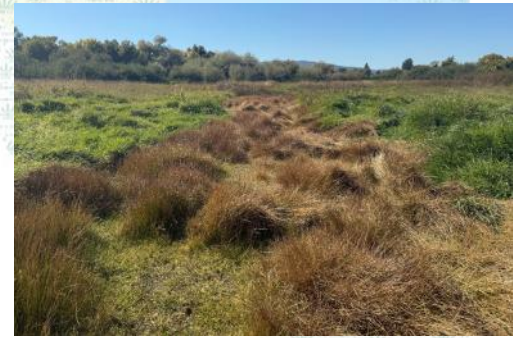
# Restoration Plan: Manning Creek

## Design goals:

- Keep more flow in the channel to reduce stranding and maintain passage
- Eliminate headcut barrier that is present when lake levels are low
- Restore historical channel alignments

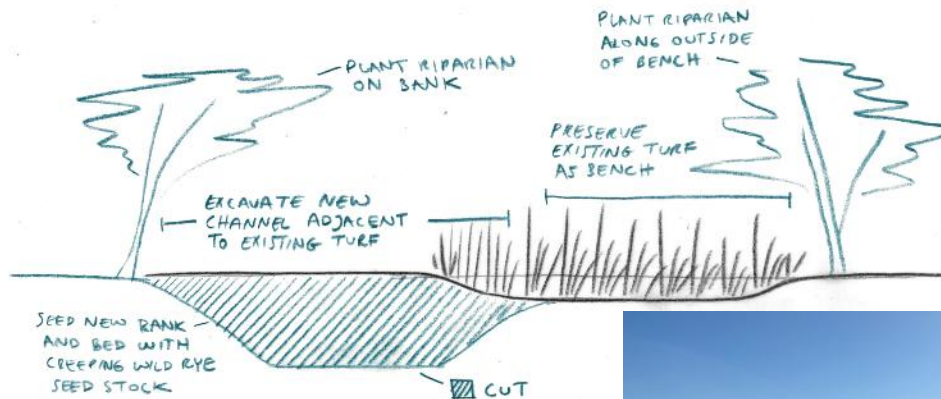
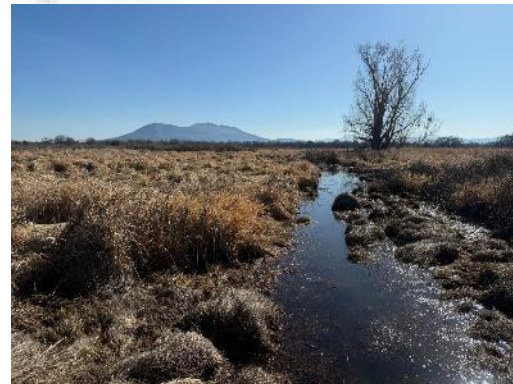
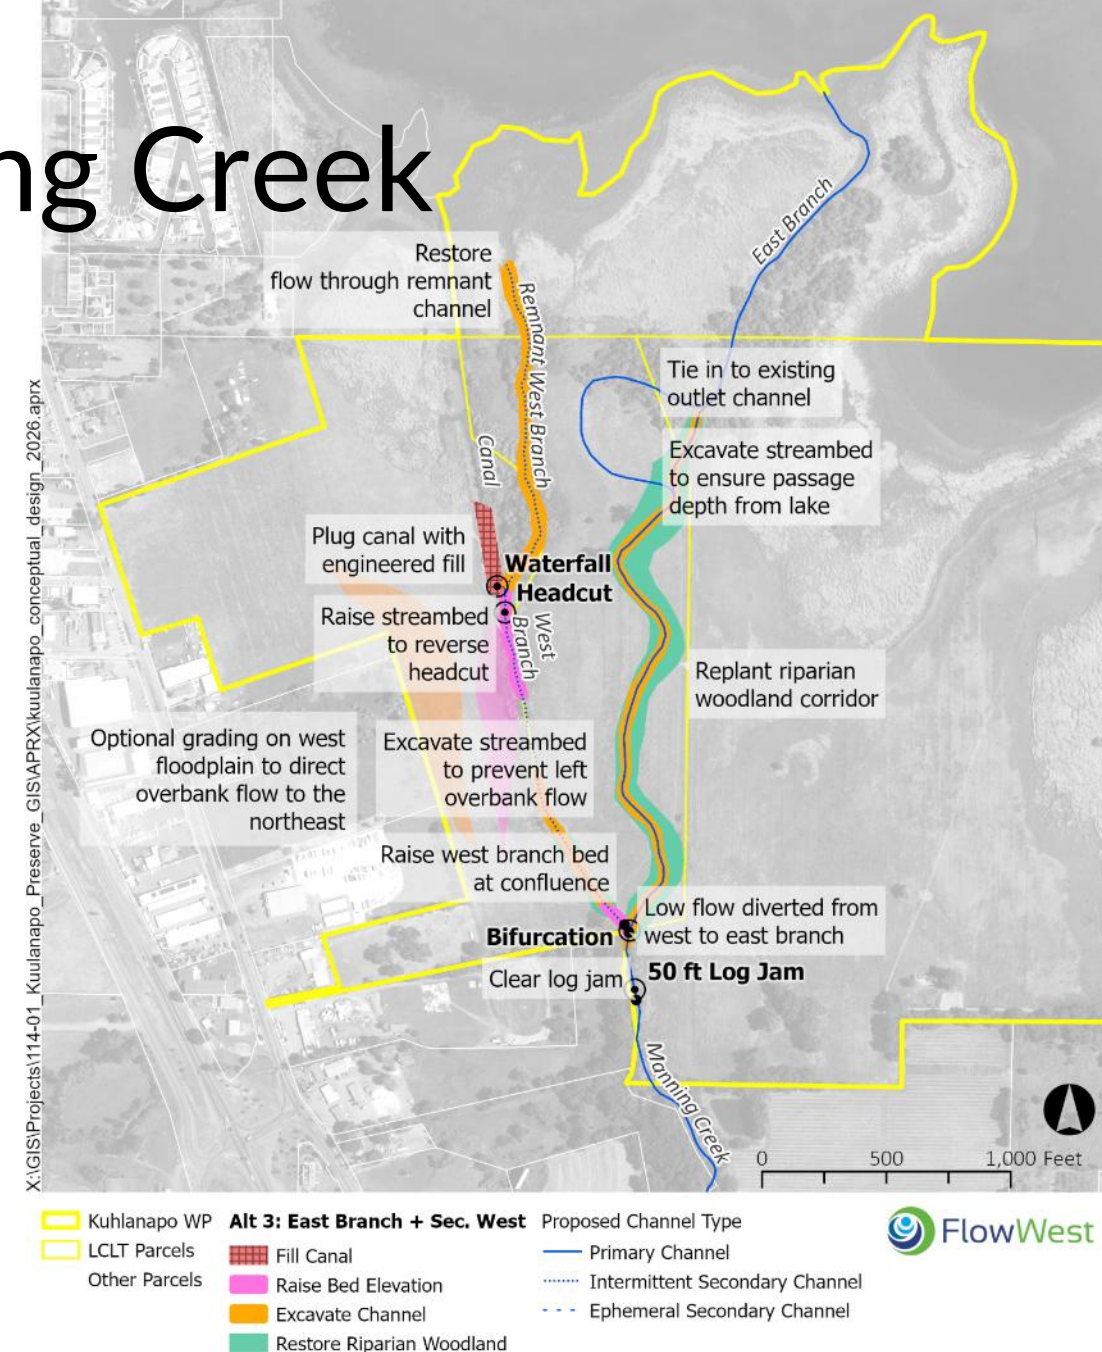
# Restoration Plan: Manning Creek

- Considered 5 different design alternatives
- Preferred alternative restores the main flow path through the historical meandering east branch
