# Kuhla'Napo Wetland Preserve Restoration Planning Project

Angela De Palma-Dow & Merry Jo Velasquez,  
Lake County Land Trust

**Today: Planning Project 292-acre Kuhla'Napó Preserve in Big Valley Wetland Complex on Manning Creek**

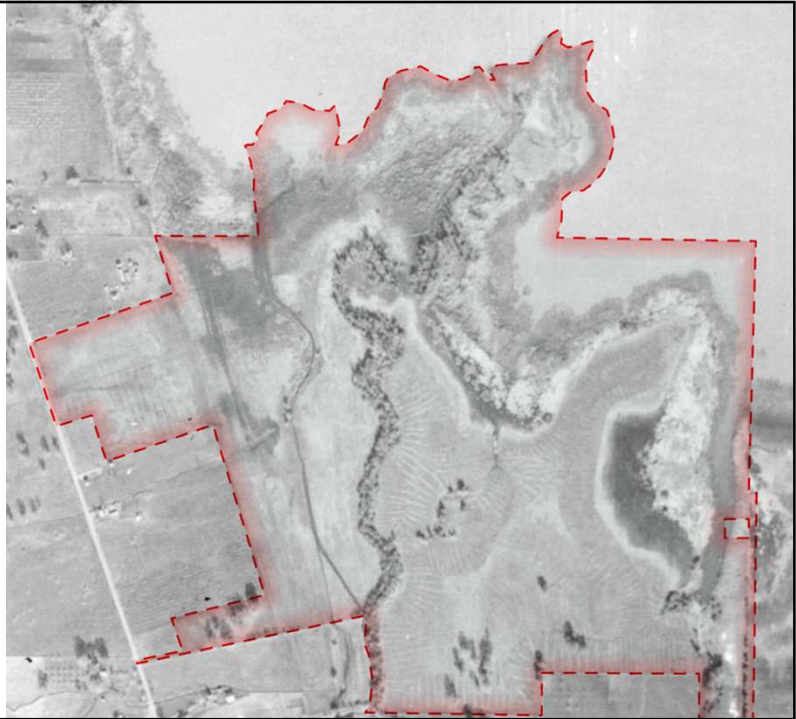
## Manning Creek Delta 1942

- Manning Creek flows through east branch riparian corridor
- Connects to lake at Manning Creek Delta tule wetland complex

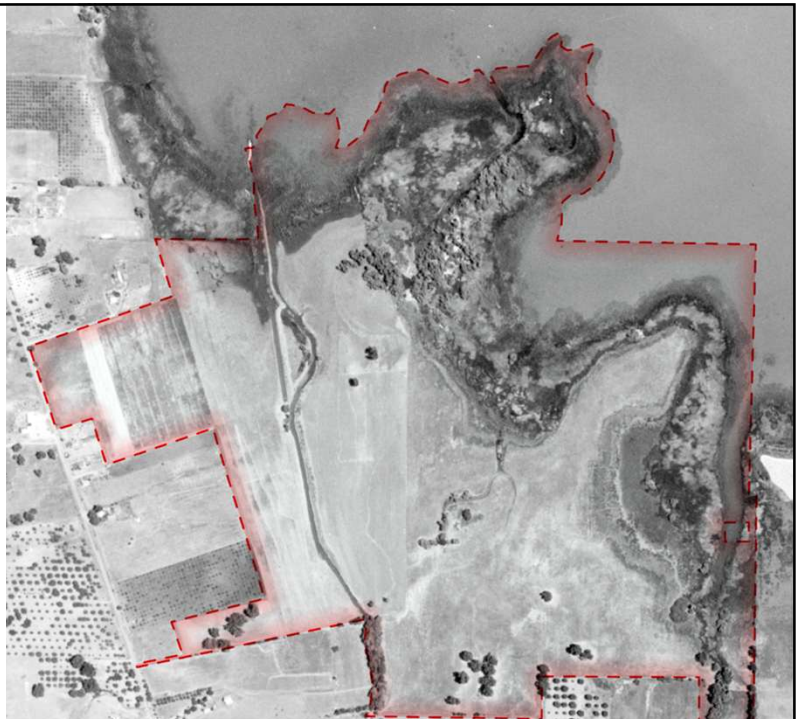
## Manning Creek Delta 1952

- Poof! Manning Creek east branch riparian corridor is gone
- Flow redirected through west branch agricultural canal
- Straightened, hardened, hydromodified

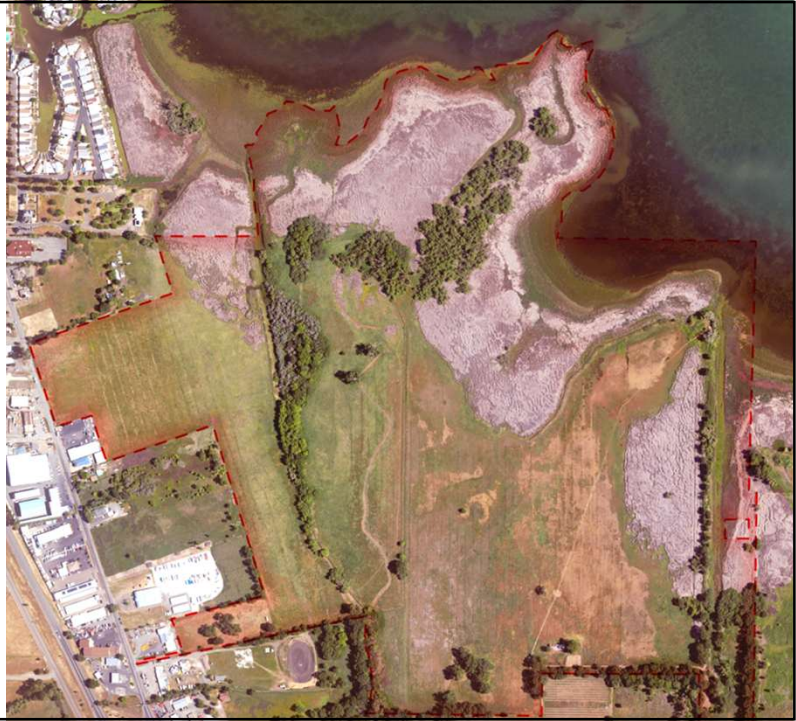
## Manning Creek Delta 2022

- Steep head cut is hitch passage barrier
- East branch now flows as a secondary channel
- Tule wetlands disconnected from the rest of the floodplain by levees

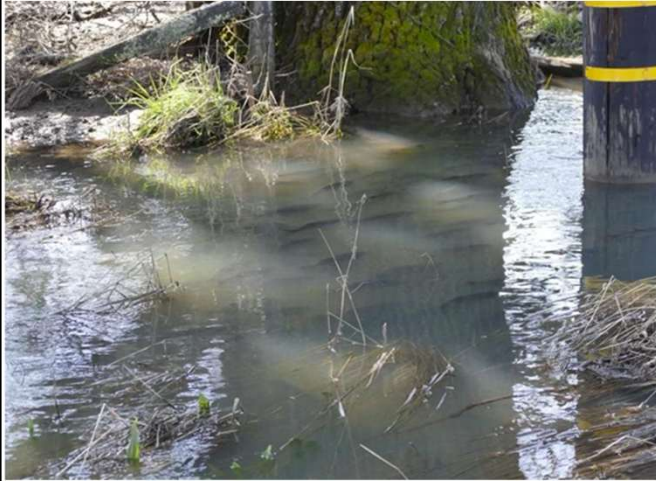
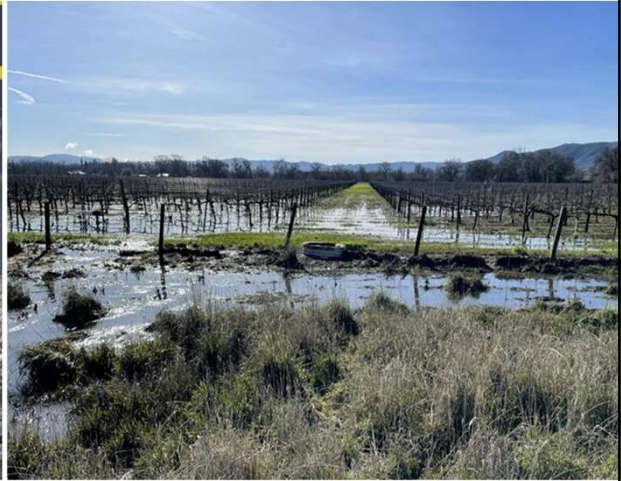
## Fish barriers and Flooding at site

*Contribute to fish strandings, sediment and nutrient leaching*

West Channel Manning Creek straightened, deepened, native vegetation removed and previous wetland drained

Remnant secondary Manning Creek Channel, blocked, debris accumulation, contributes to erosion and blow outs

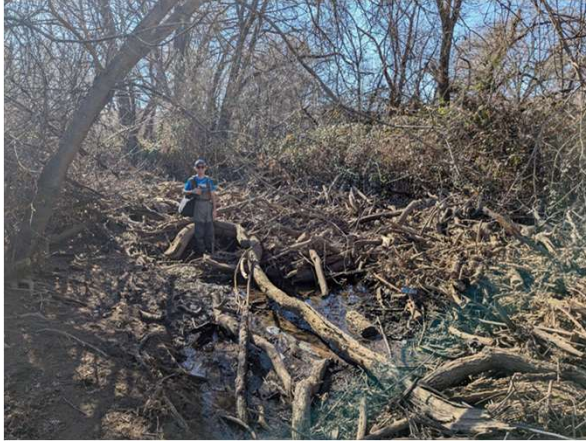
## Fish Passage Barrier Removed in 2025

parcel acquired in 2020

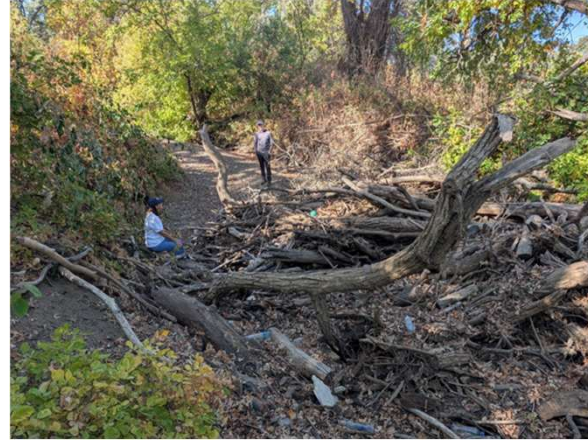
## Current Fish Passage Barrier (image taken 10/12/2026)

parcel acquired in 2026

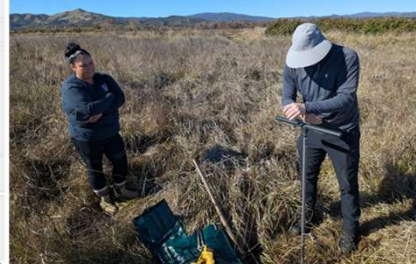
### Installation with BVBPI Tribal monitor present
