# Fish Passage Improvements on Manning Creek as Part of the Kuhlmanapo Wetland Preserve Restoration Project

**Angela De Palma-Dow & Merry Jo Velasquez,**  
Lake County Land Trust

**Anthony Falzone,** Flowwest

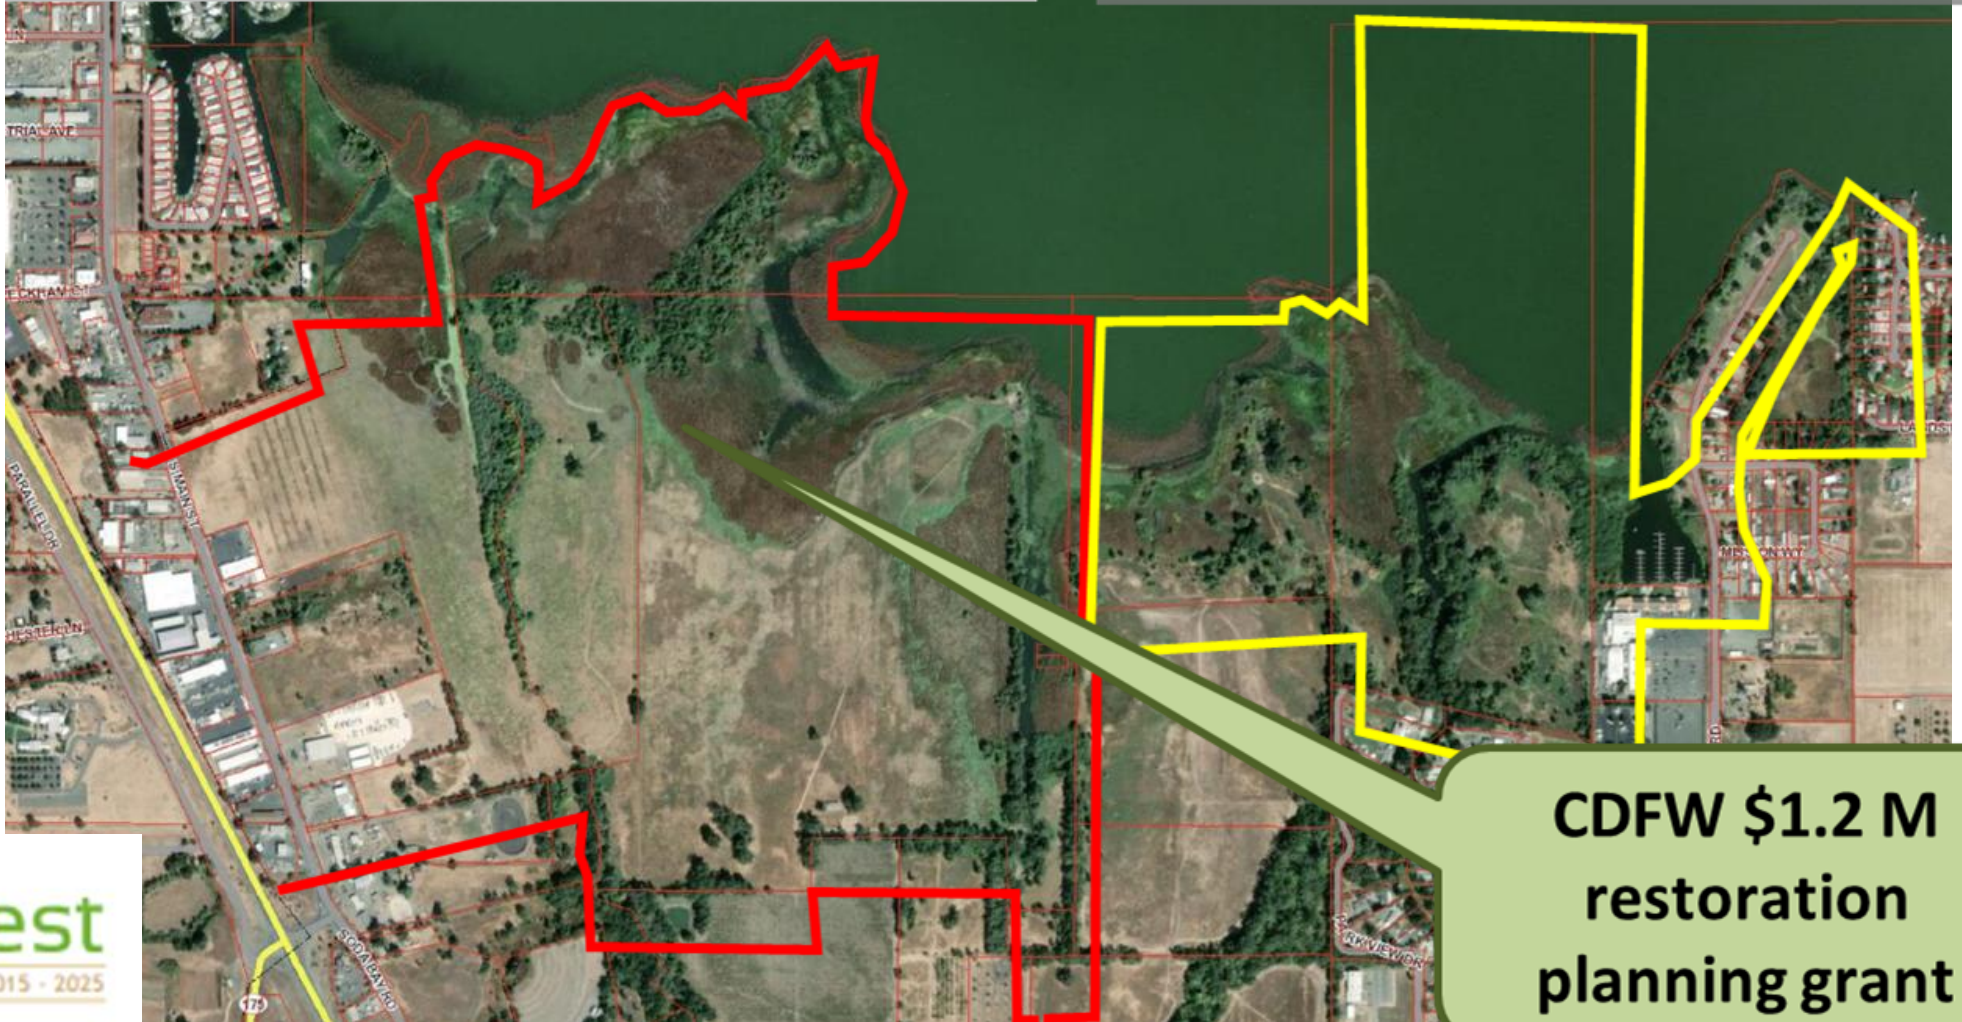
# Today: Planning Project 283-acre Kuhlano Preserve in Big Valley Wetland Complex on Manning Creek

**Kuhlano Wetland Preserve**

**Big Valley Tribal Lands**

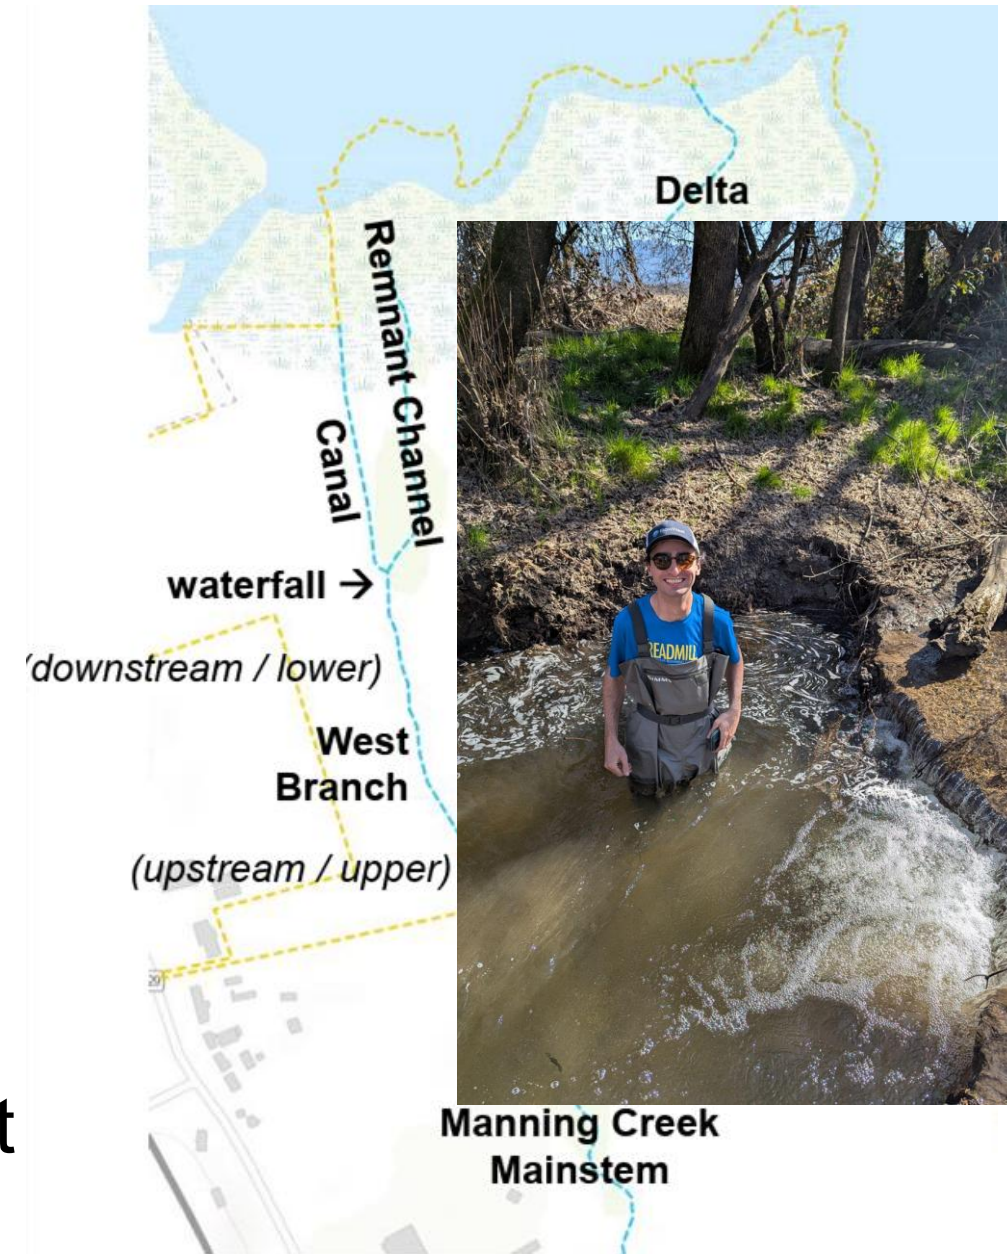
# Current Day Issues on Site

- Head cuts (waterfalls)
  - Passage barriers for Hitch
  - Bed and bank erosion
- Reduced channel conveyance
  - Flooding where Hitch get stranded
  - Contribute nutrients
- Sediment deposition and LWD jams
  - Clogged stream channels
- Loss of native, culturally important plant species

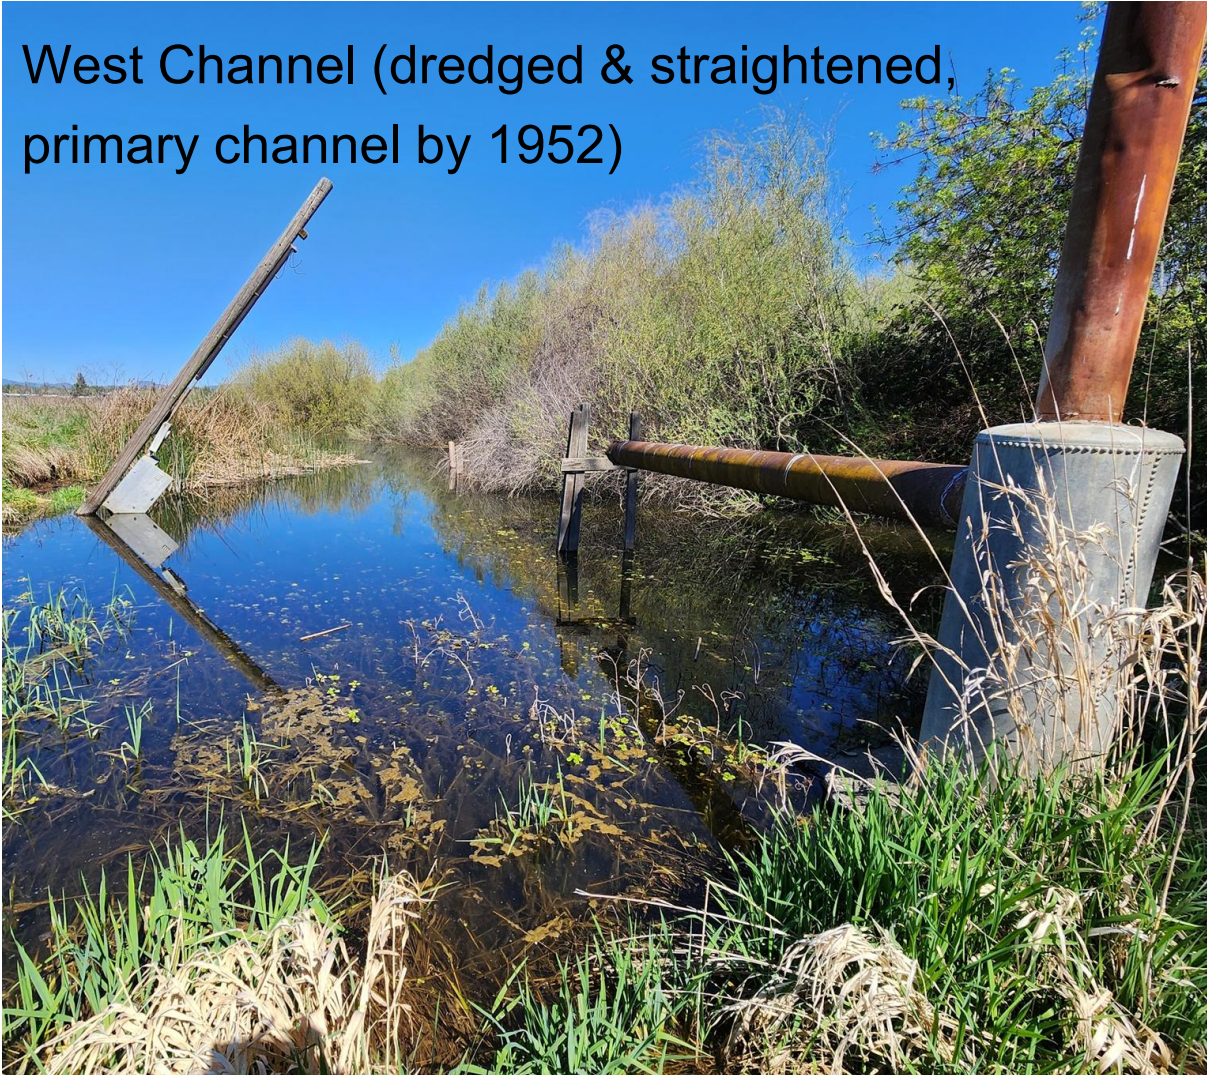
West Channel (dredged & straightened, primary channel by 1952)

# The east and west Manning Creek today is not preferred hitch habitat

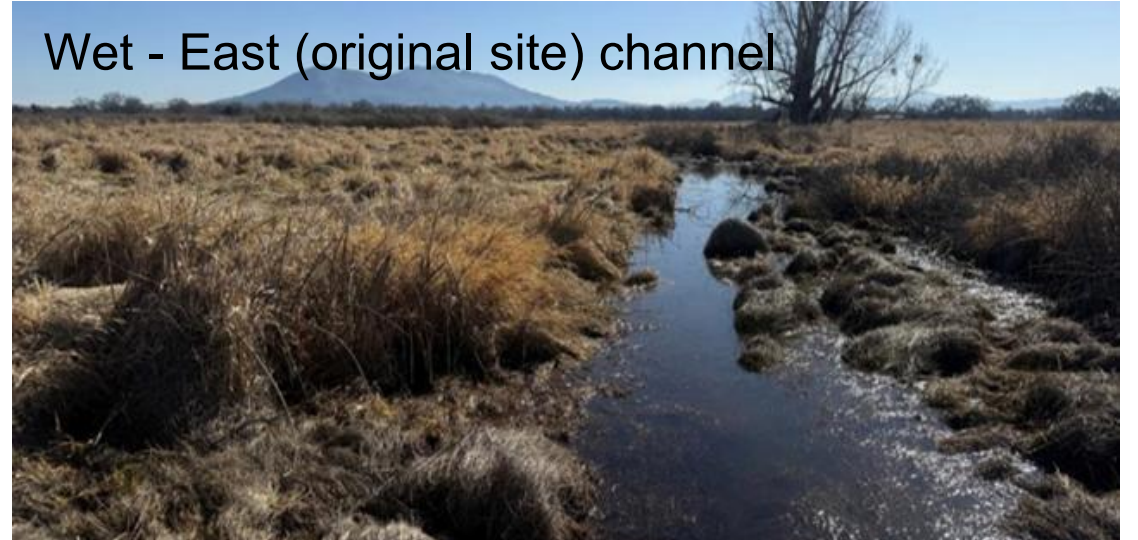
Wet - East (original site) channel

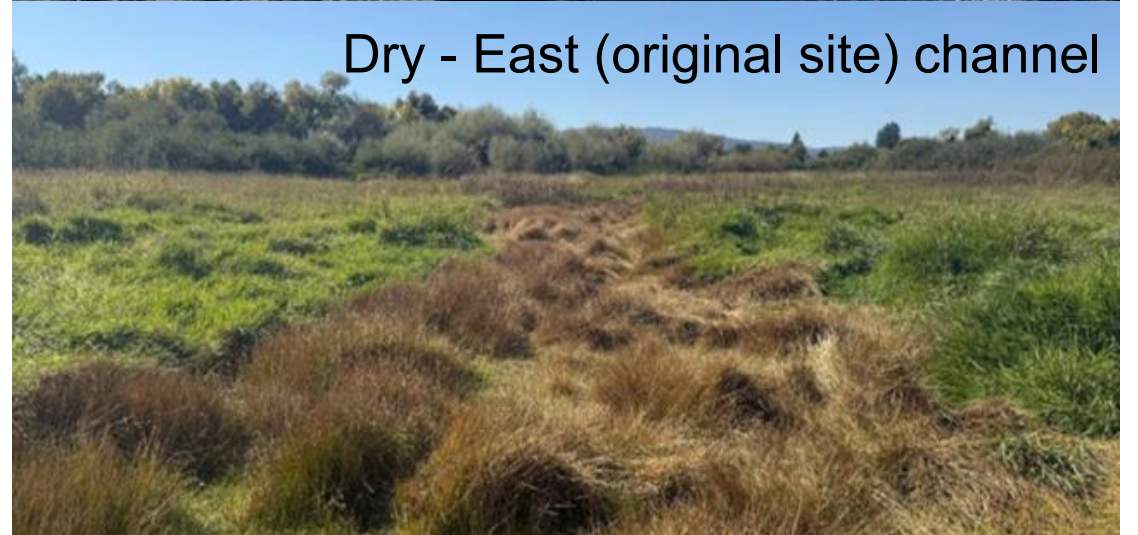
Dry - East (original site) channel

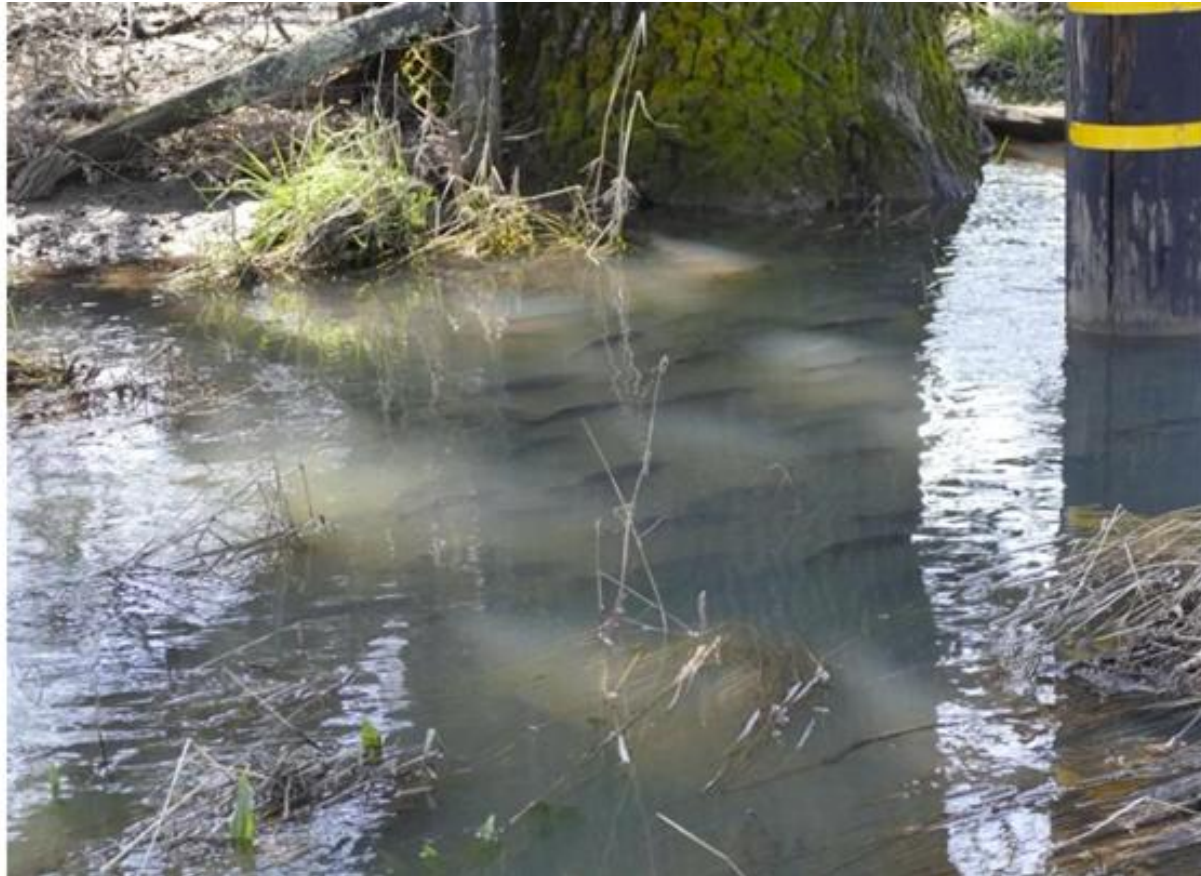
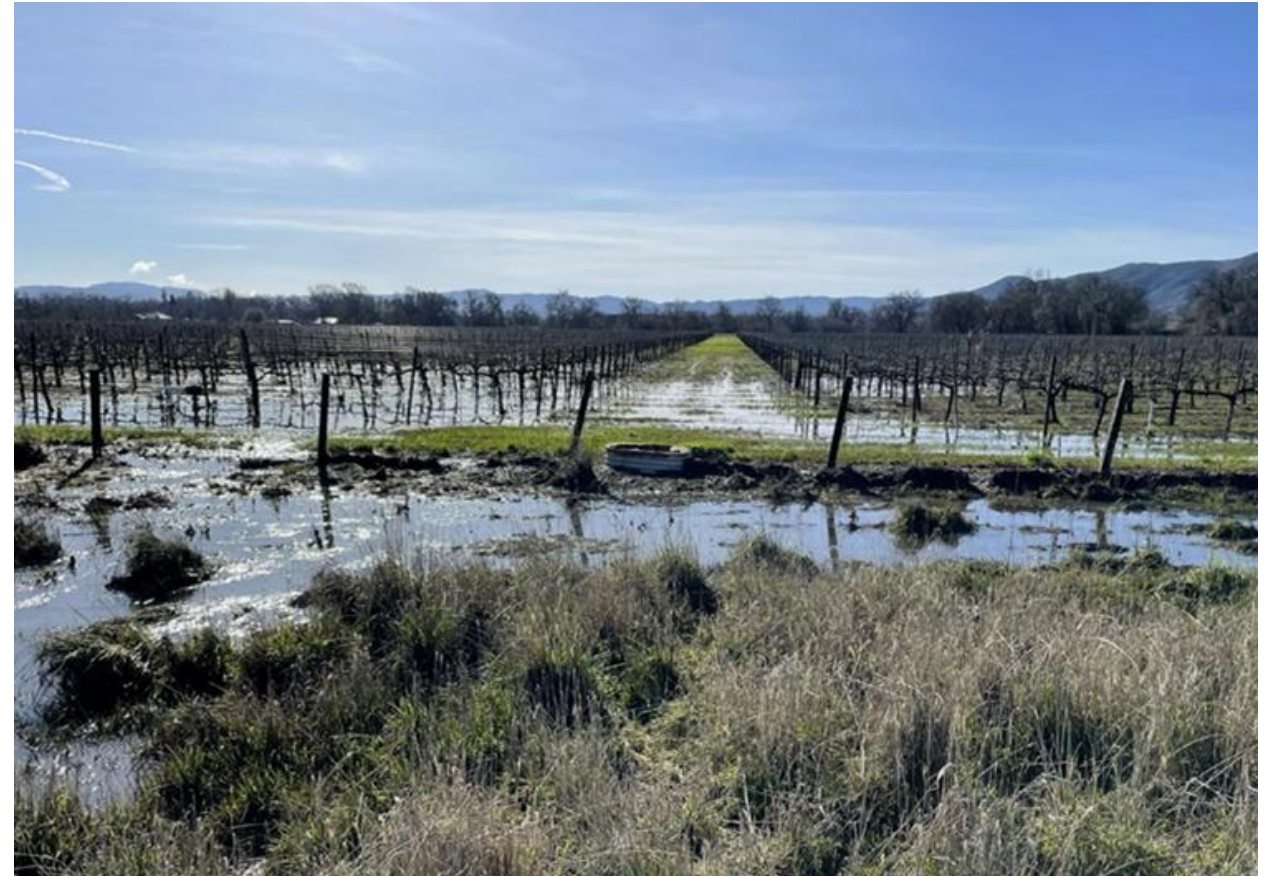
# Flooding at site

*Contribute to fish strandings, sediment and nutrient leaching*

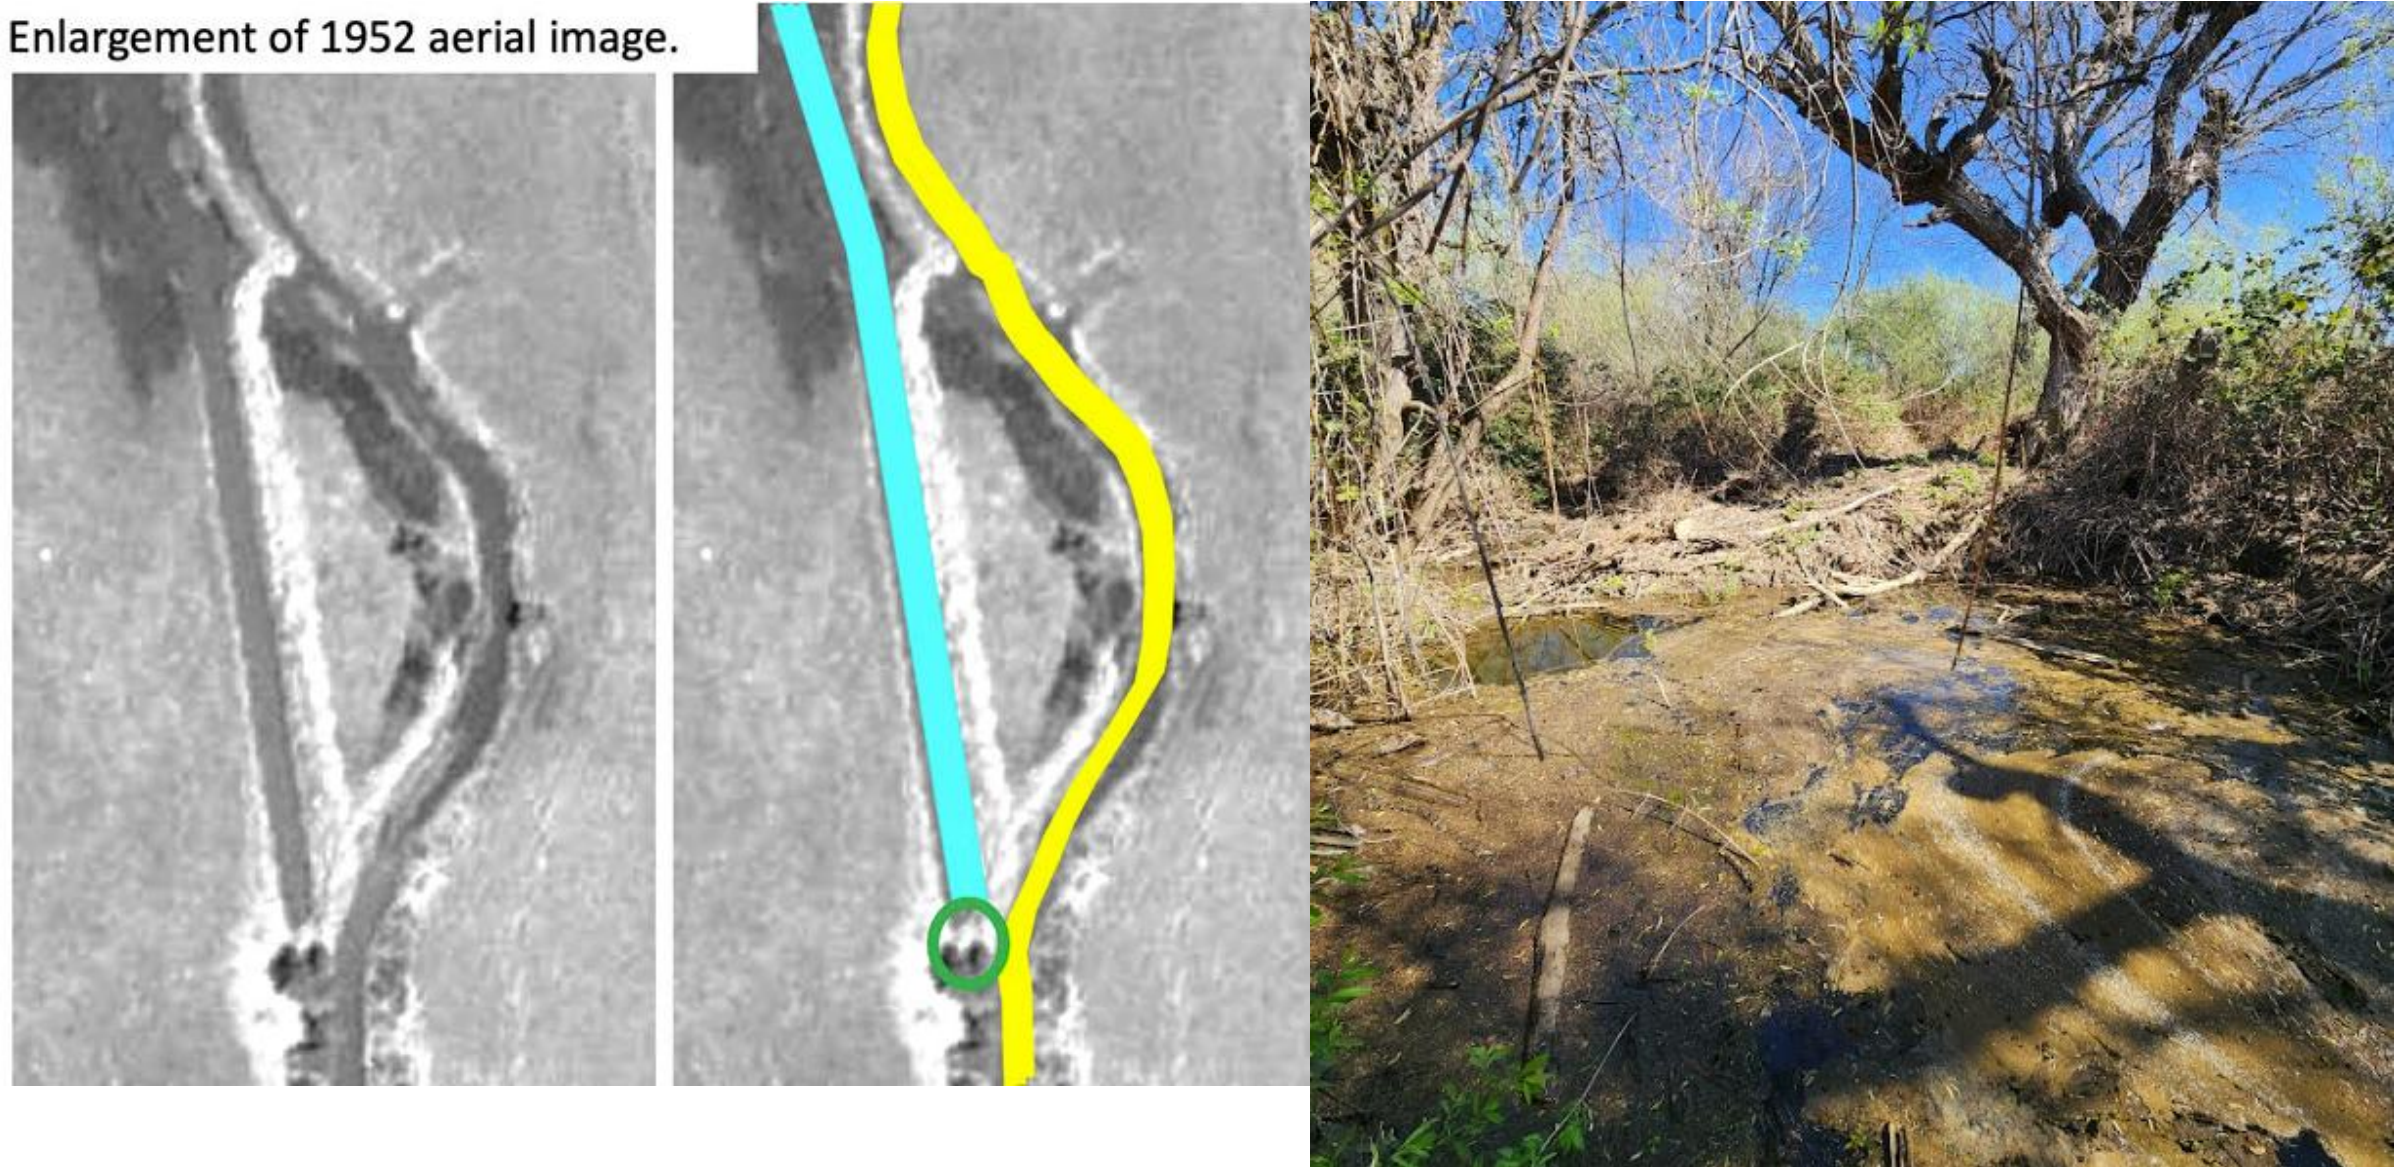
# Head cuts and remnant channel barrier

Enlargement of 1952 aerial image.

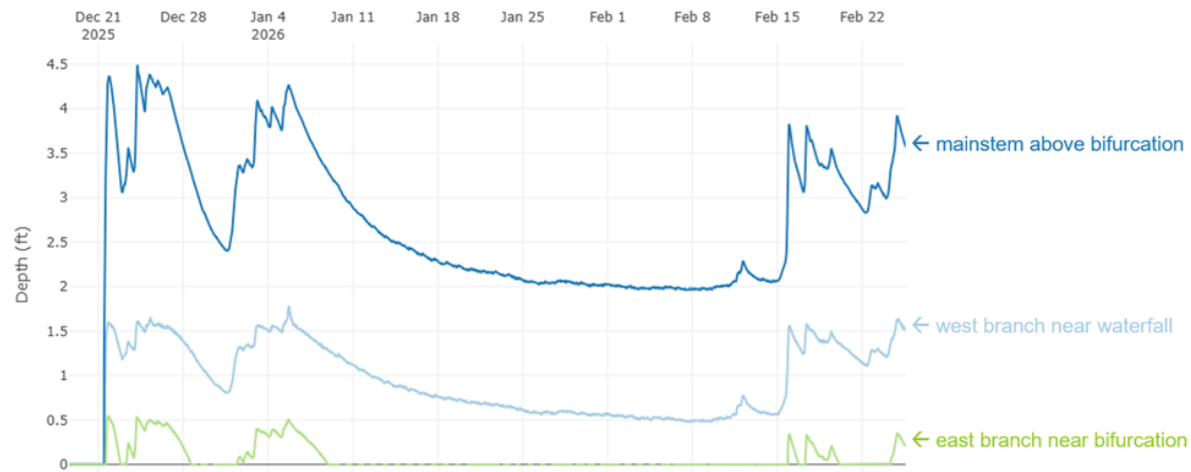
## MONITORING LOCATIONS

# Data for Design

- Stage, Temperature
- Shallow Groundwater Elevation
- Real Time Data On our Restoration Website

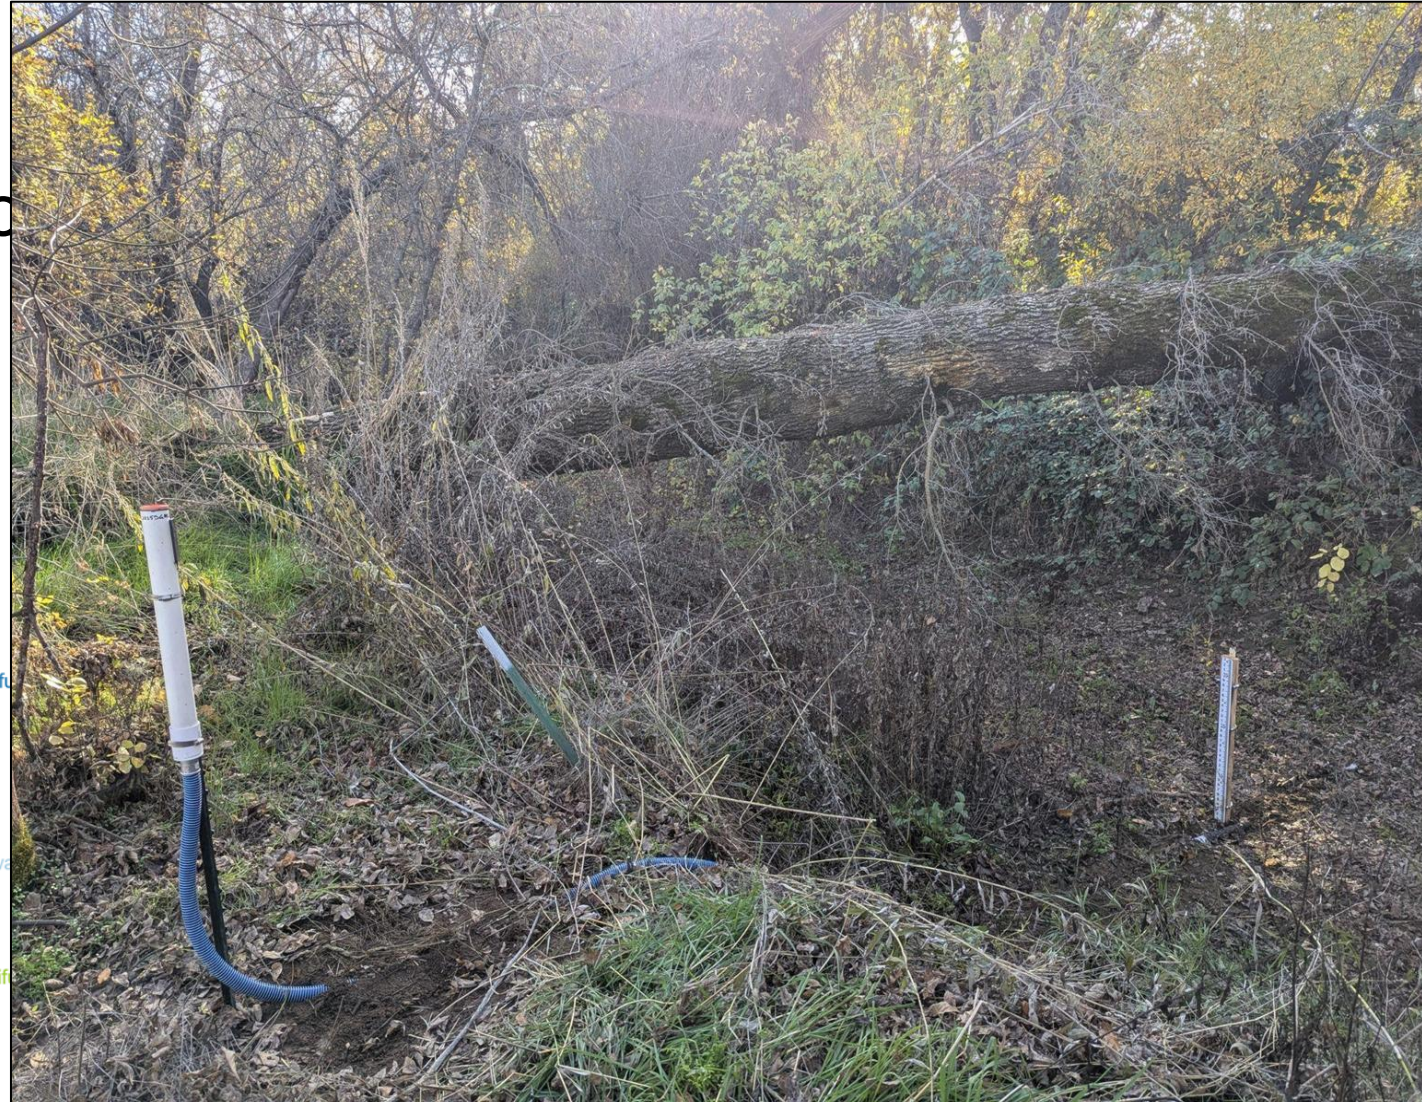
## MONITORING LOCATIONS

# Data for Design

- Stage, Temperature
- Shallow Groundwater Elevation
- Real Time Data On our Restoration Website

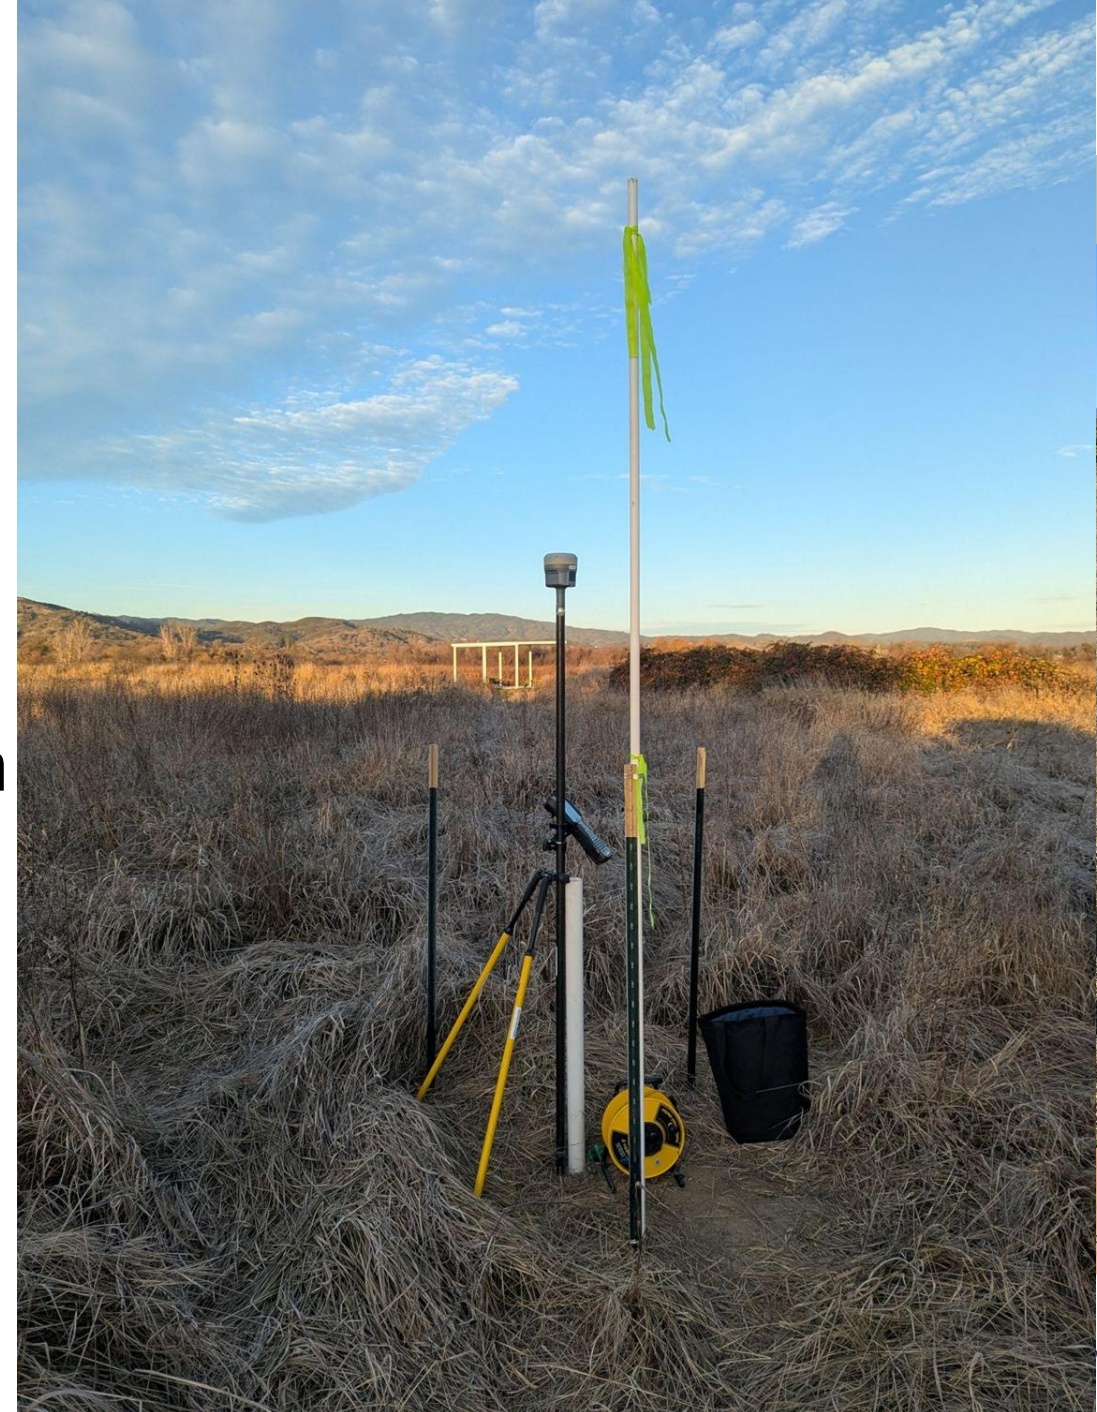
# Shallow groundwater Monitoring

- Hand augered 10 shallow groundwater monitoring wells
- Tribal monitor on site
- Pressure transducers record depth and temperature
- Installed in transects to capture different
  - soil types
  - vegetation communities
  - distance from the lake

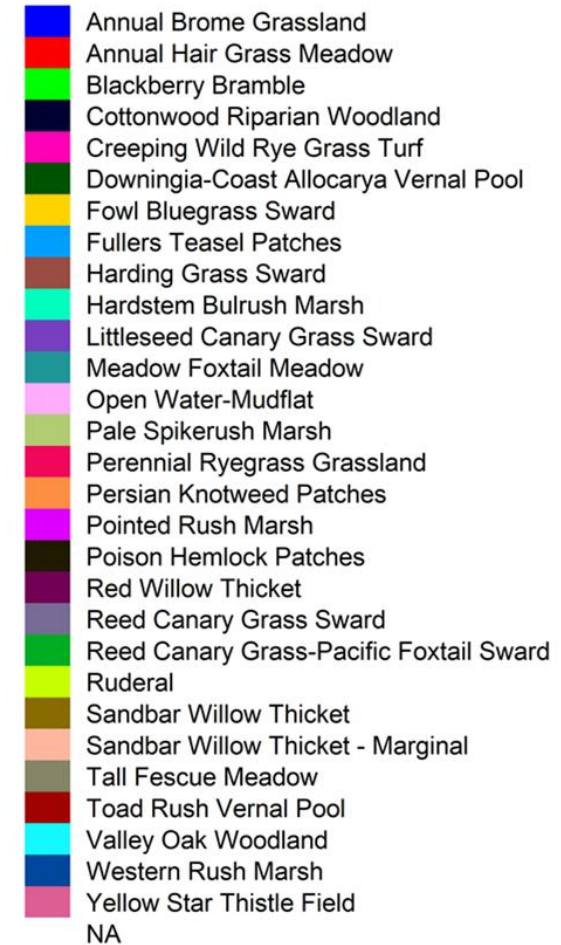
# Vegetation Mapping

- established tule beds
- non-native invasives
- Oak woodlands
- Change in wetland extent between the last drought and now
- Vernal pool protection
